APPENDIX D:

**One-Page Summary Sheets for
Stormwater Problem Areas**

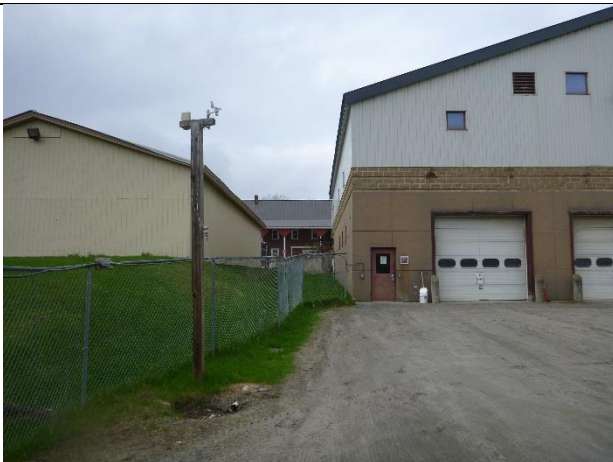
Photo 1: Rooftops draining to catchbasin

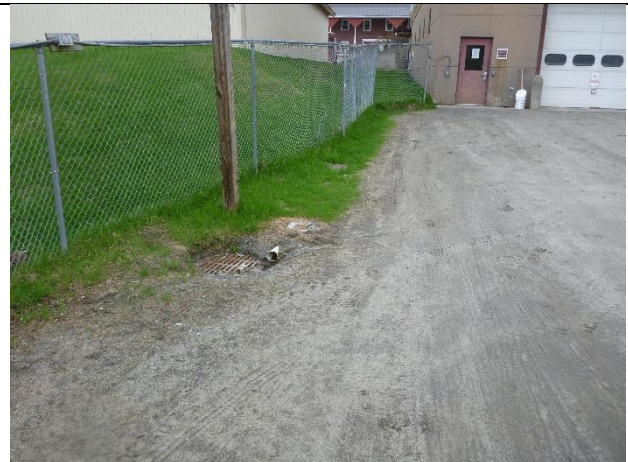
Site Description: Runoff from a large rooftop area flows on to a high traffic gravel parking area before draining to a catchbasin, significant rilling was observed along the flow path. The catchbasin is piped directly to a stream to the east.

Photo 2: Erosion along edge of unpaved parking area flowing in to the catchbasin

BMP Description: Install a grassed swale along the fence to separate the “clean” rooftop runoff from the unpaved parking area, stabilize the erosion at the catchbasin inlet. **This project was completed in July 2017 by a Northwoods Stewardship Center work crew.**

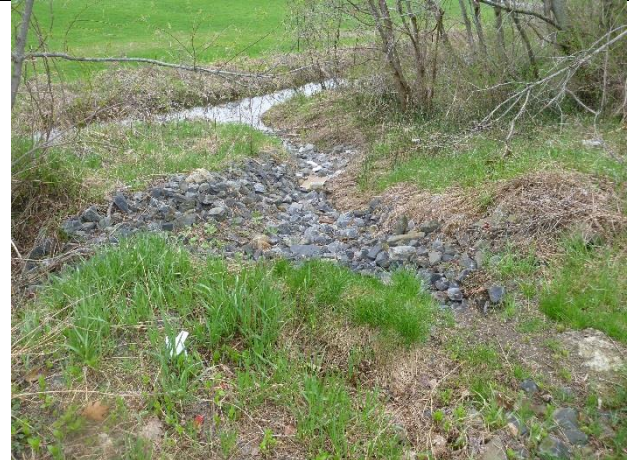
Site Description: Three gullies have formed along the steep bank at the edge of the parking area. Winter plowing has altered the grading so runoff does not drain to the armored swale.

Photo 2: Armored swale that does not receive significant runoff due to parking lot grading.

BMP Description: Excavate the loose soil and plowing materials along the edge of the parking lot and install an armored spillway, grade the edge of the parking lot to direct all flow to armored spillways, and create a winter plowing plan to minimize future gully formation.

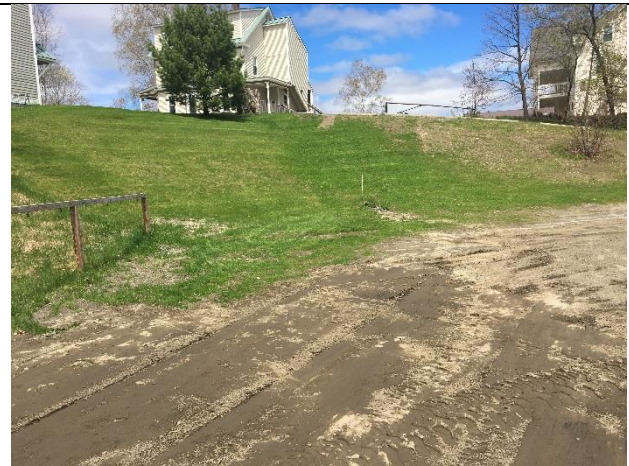
Photo 2: Erosion from the stormwater pipe across the gravel parking area.

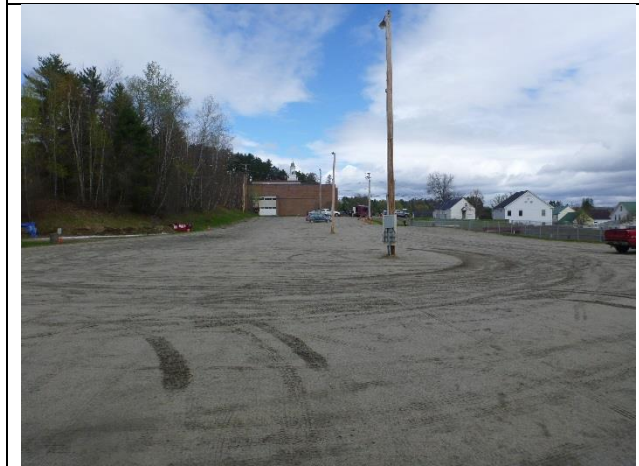
Photo 1: Large gravel parking lot draining south.

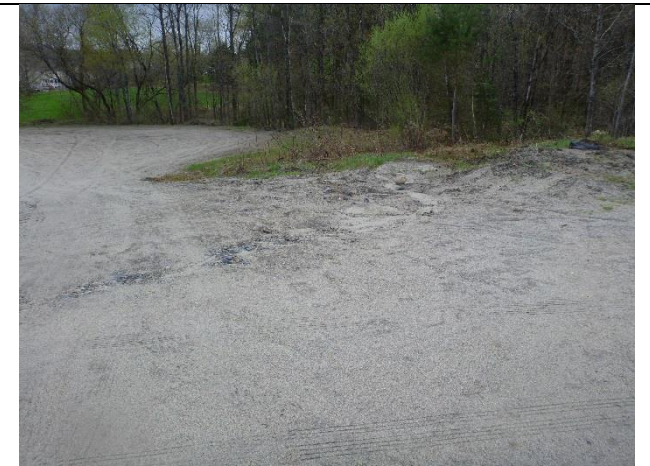
Photo 2: Water bar directs runoff from most of parking lot to a small green area on top of the slope.

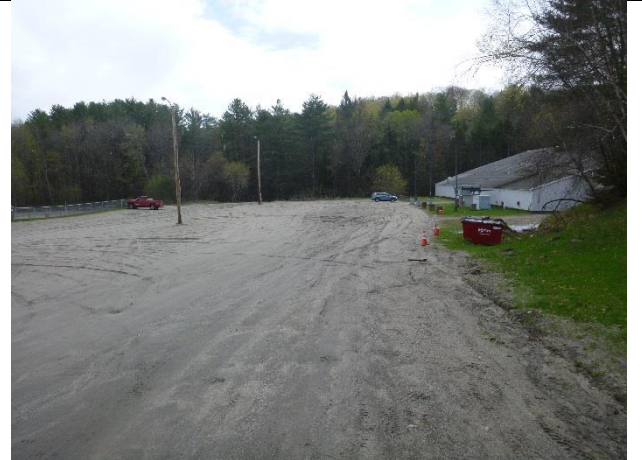
Photo 2: Area draining to the catchbasin from College Road.

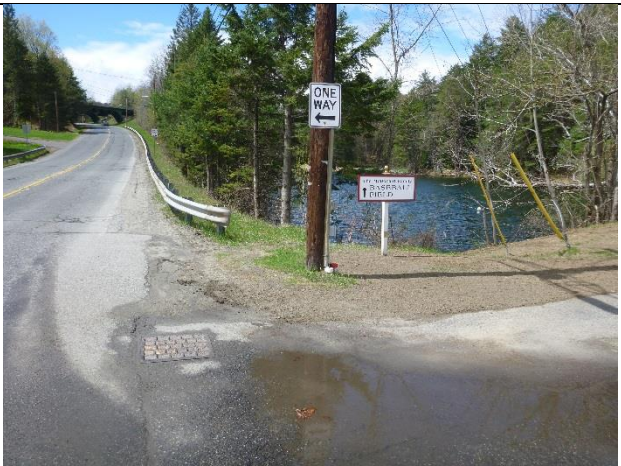
Photo 1: Catchbasin located at the Institute Circle and College Road intersection, drains to the pond.

BMP Description: Repair the broken curb to prevent runoff from eroding along the edge of pavement. Establish vegetation along the bank. The catchbasin should be inspected and will likely require more frequent cleanout.

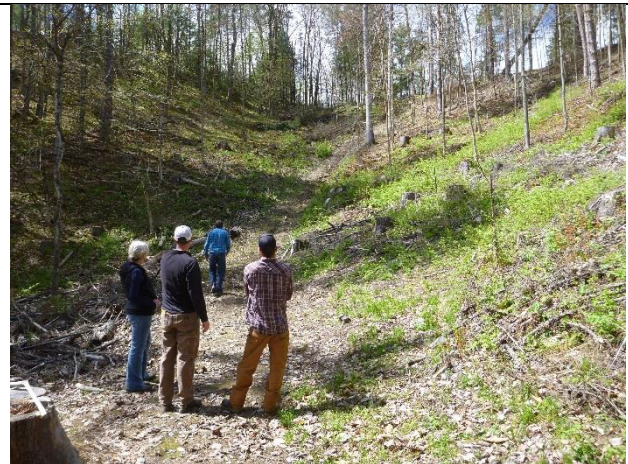
Photo 2: Major erosion along a steep and straight trail section with no stabilization structures.

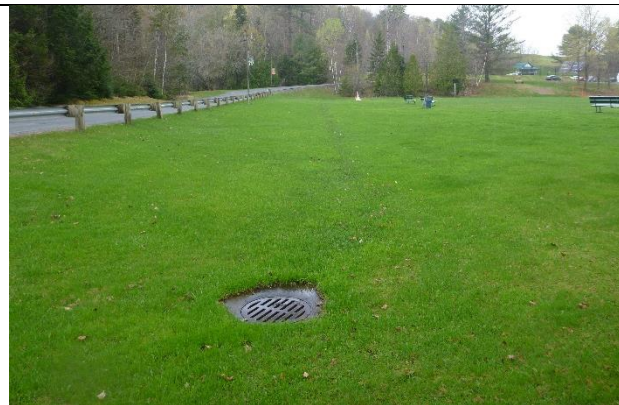
Photo 1: Mowed swale along varsity field draining to catchbasin

BMP Description: Implement a “no-mow” buffer along the swale and plant appropriate wetland shrub species to improve nutrient retention and reduce wet areas along the field. Minor excavation to better define the swale would likely improve field conditions. Project may include additional partnership with Health and Safety to include a footpath near the guardrail to keep students off the road.

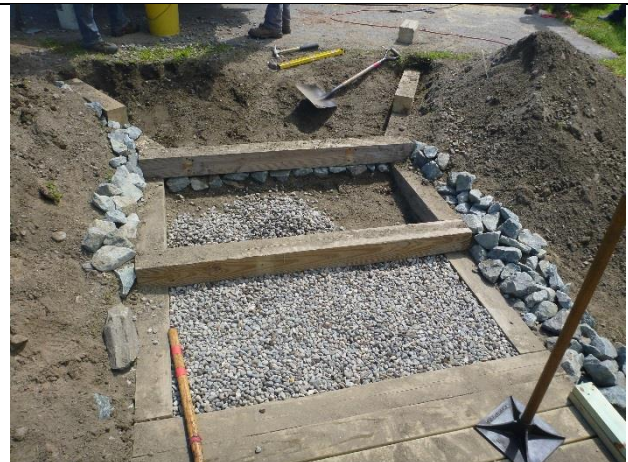
Photo 2: Installation of infiltration steps from parking lot to footbridge.

BMP Description: Install a footbridge across the swale and create a defined walking path with a stone and/or hedge border. Till compacted soil and establish vegetation. Boxed infiltration steps will reduce runoff from the parking lot. **This project was completed in July 2017 by a Northwoods Stewardship Center work crew.**

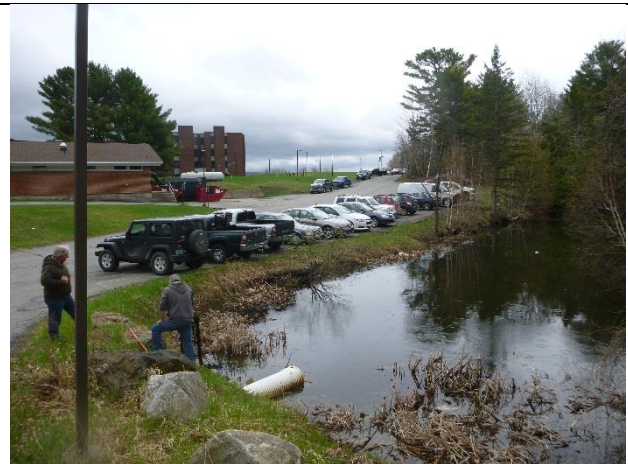
Photo 2: View of watershed draining to the project site.

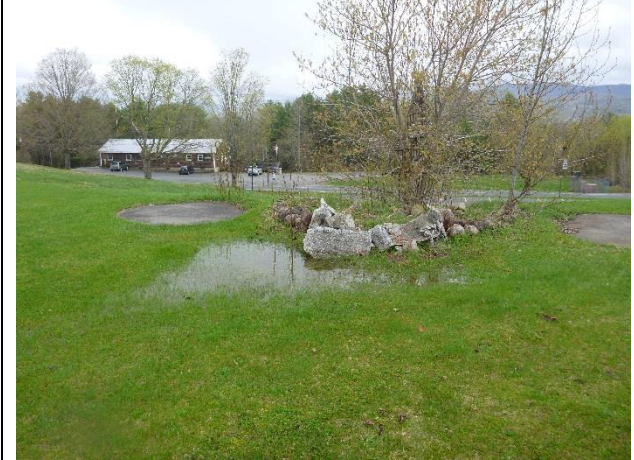
Photo 1: Existing low point at proposed rain garden location.

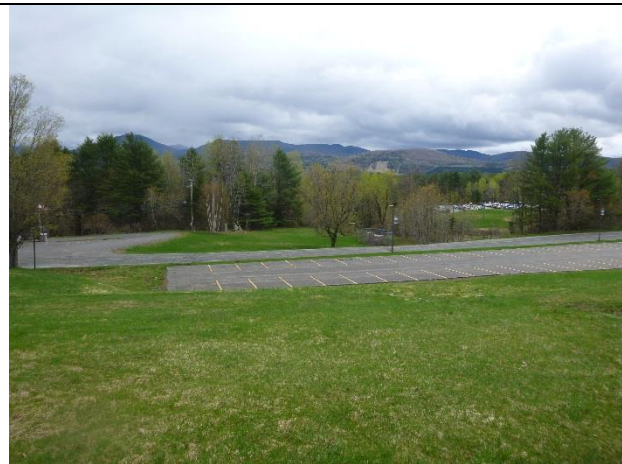
Photo 1: Potential location of BMP at the end of the parking lot.

BMP Description: Improve the swale along the parking lot and install a gravel treatment wetland to increase nutrient uptake. The installation will remove 2-4 parking spaces from the end of the lot. The CMP culvert under College Road should be considered for replacement during construction. Winter plowing will no longer be able to stockpile snow in this area.

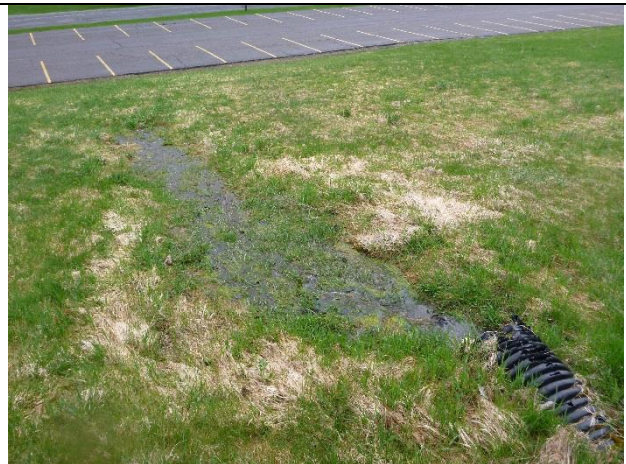
Photo 2: High nutrient runoff from the baseball fields flowing to the site.

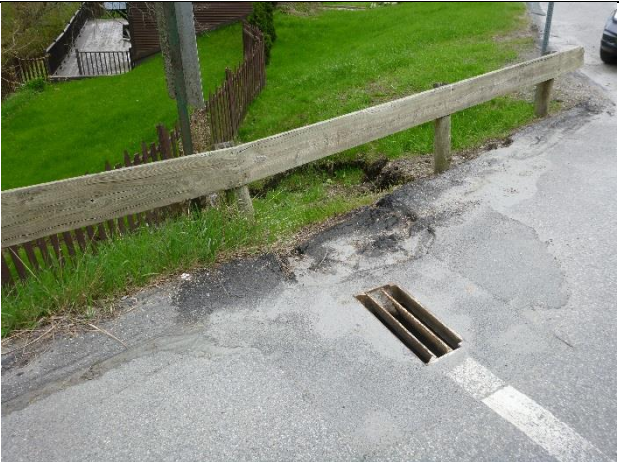
Photo 2: Evidence of recent pavement repairs and drainage point off of the road.

Additional Project Benefits Description: The recent pavement repairs and the ongoing gully erosion show that this is a chronic problem area. The gully erosion is beginning to undercut the guardrail and the edge of the pavement.

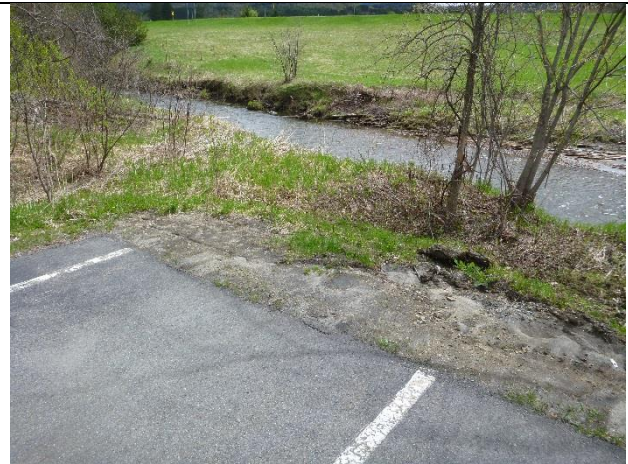
Photo 2: Minor gully erosion along stream bank and exposed soil from plowing.

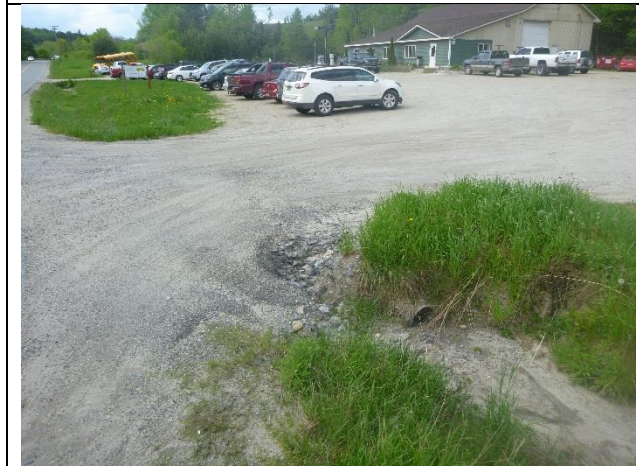
Photo 1: Gully erosion and significant sediment loading at the east entrance.

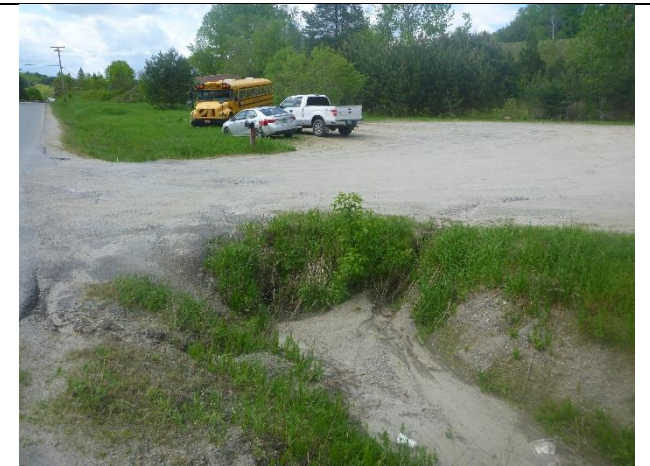
Photo 2: Gully erosion and significant sediment loading at the west entrance.

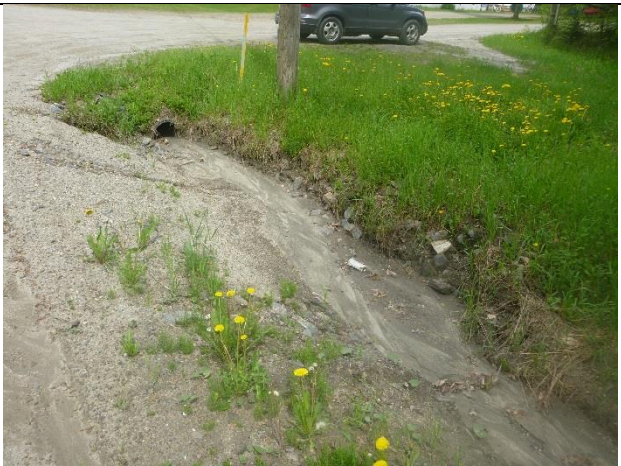
Photo 1: Gully erosion and significant sediment loads in ditch.

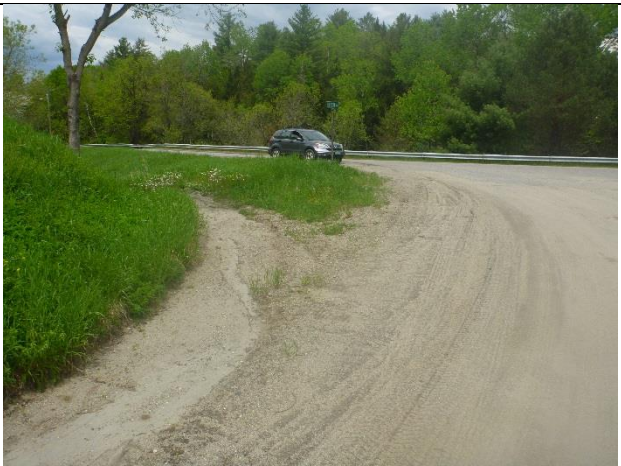
Photo 1: Ditch at the top of Tute Hill Road filled with sediment

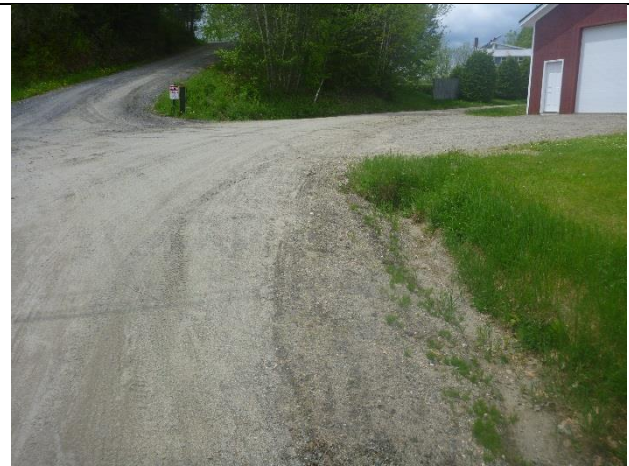
Photo 2: Steep private road and gravel parking draining in to the ditch with rill and gully erosion.

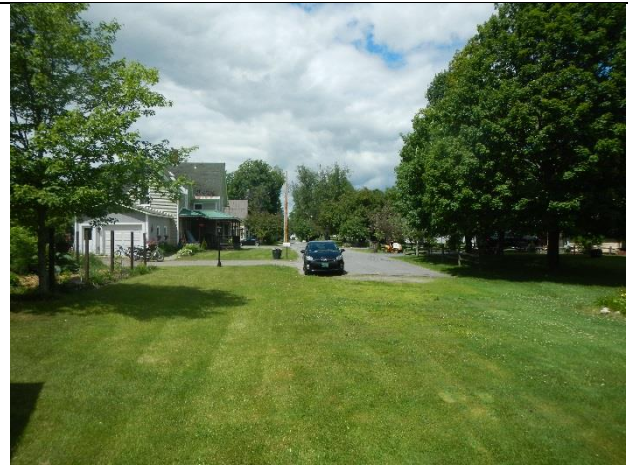
Photo 2: Residential area partially draining to the gully site.

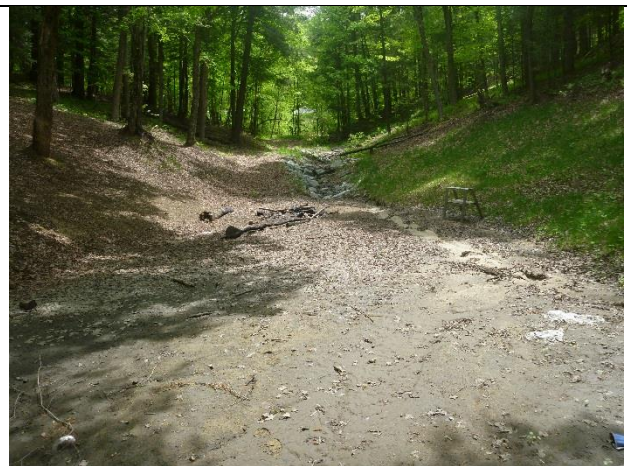
Photo 1: Sediment buildup in the basin with active rilling and erosion.

BMP Description: Stabilize the channels from the culvert outlets and repair stone step near pond inlet. Clean out the pond and install a new outlet structure with a low flow orifice and raise the elevation of the primary outlet. Site maintenance should be minimal and likely less than what is currently required.

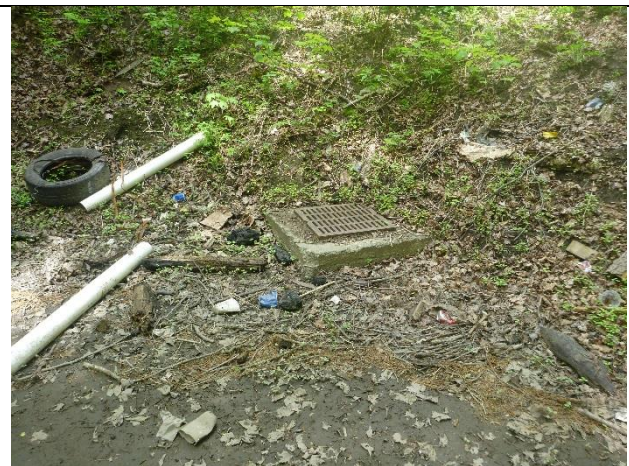
Photo 2: Outlet structure approximately 6" above the basin bottom.

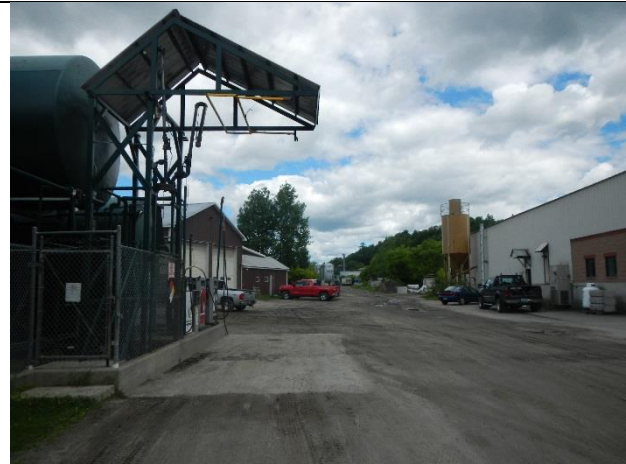
Photo 2: Large area of gravel road and parking and rooftops draining to the site along Raymond St.

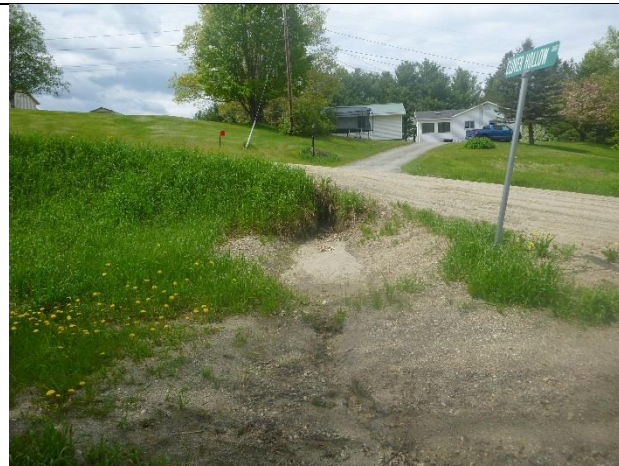
Photo 1: Large sediment deposits along Clover Hollow Rd adjacent to an intermittent stream.

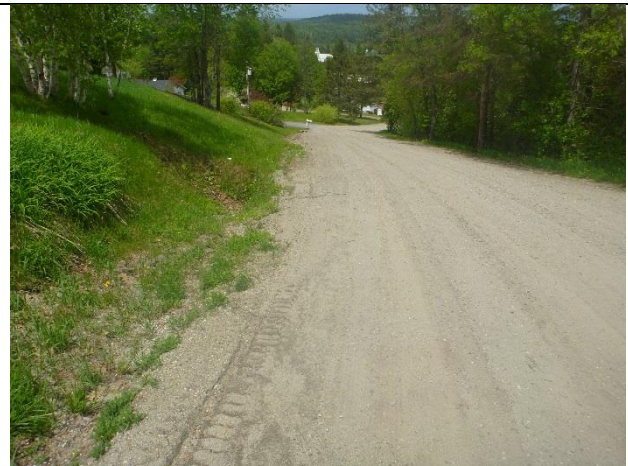
Photo 2: Steep section of road with unstable ditches.

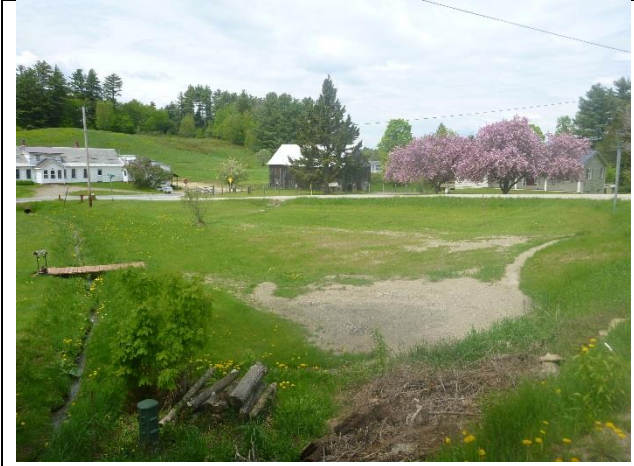
Photo 1: Large sediment deposits along intermittent stream off of Strawberry Hill.

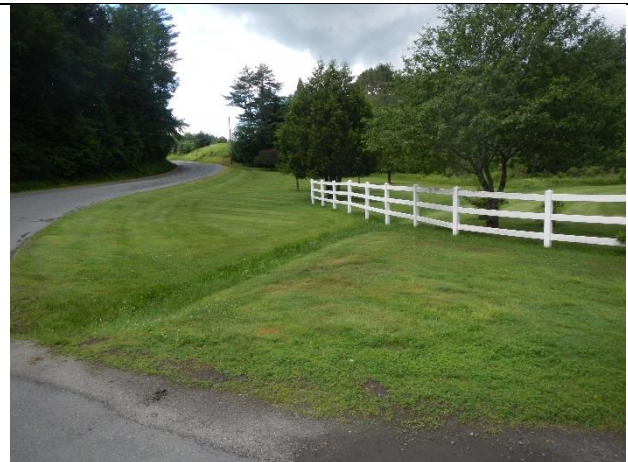
Photo 2: Outlet of wetland ditch to the roadside ditch.

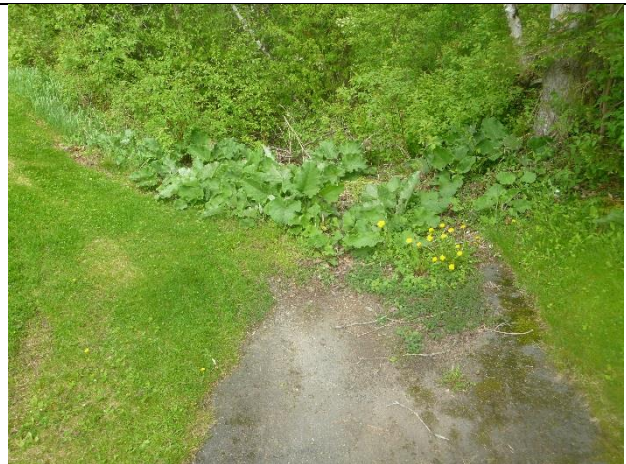
Photo 2: Outlet of ditch to steep forested slope leading to the floodplain.

BMP Description: Install a linear treatment feature to infiltrate stormwater and trap sediment and stabilize the outlet channel down to the stream.

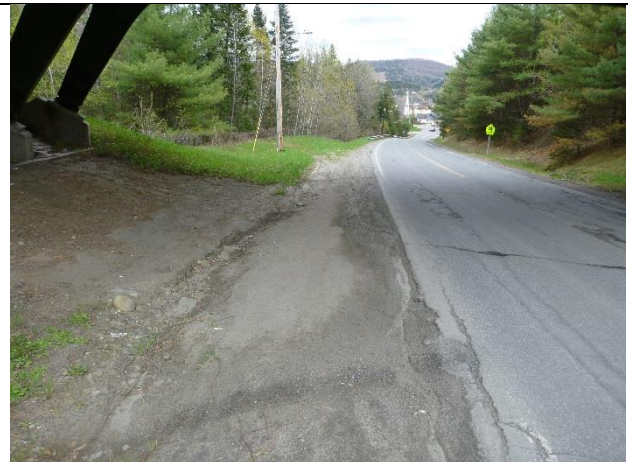
Photo 2: Two eroded flow paths along the road shoulder, some runoff continues down College Rd.

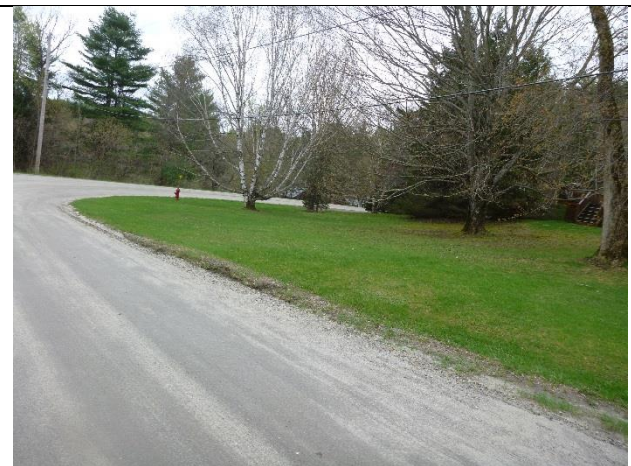
Photo 1: Poorly defined ditch spills across road causing rilling.

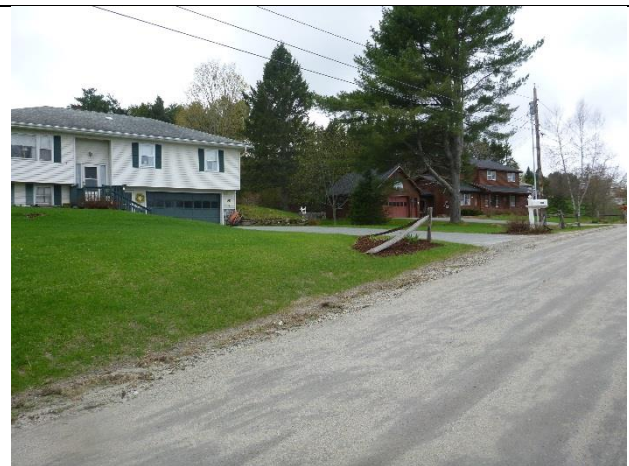
Photo 2: Erosion along road shoulder and poorly defined ditch.

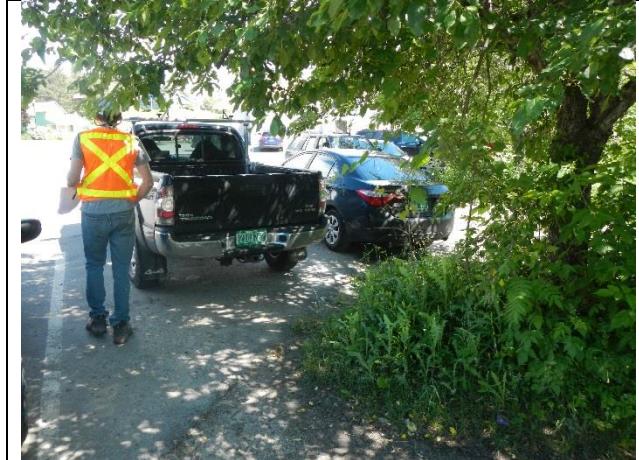
Photo 1: Compacted soil along flow path from parking lot to swale.

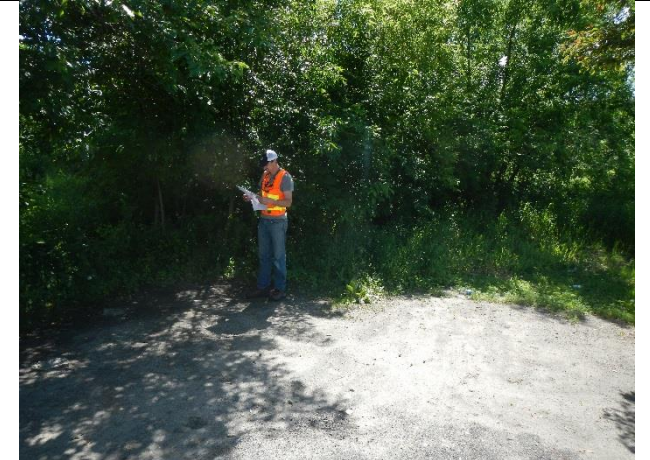
Photo 2: Existing low point with flow path down the steep bank to the river.
