# Stormwater Master Plan Town of St. Johnsbury, Vermont

PROJECT NO.

15-215

Cover:  
Illustrative  
concept design  
for a portion of  
the Oak Street  
drainage area  
before (top) and  
after (bottom)  
implementation  
of green  
infrastructure  
practices.

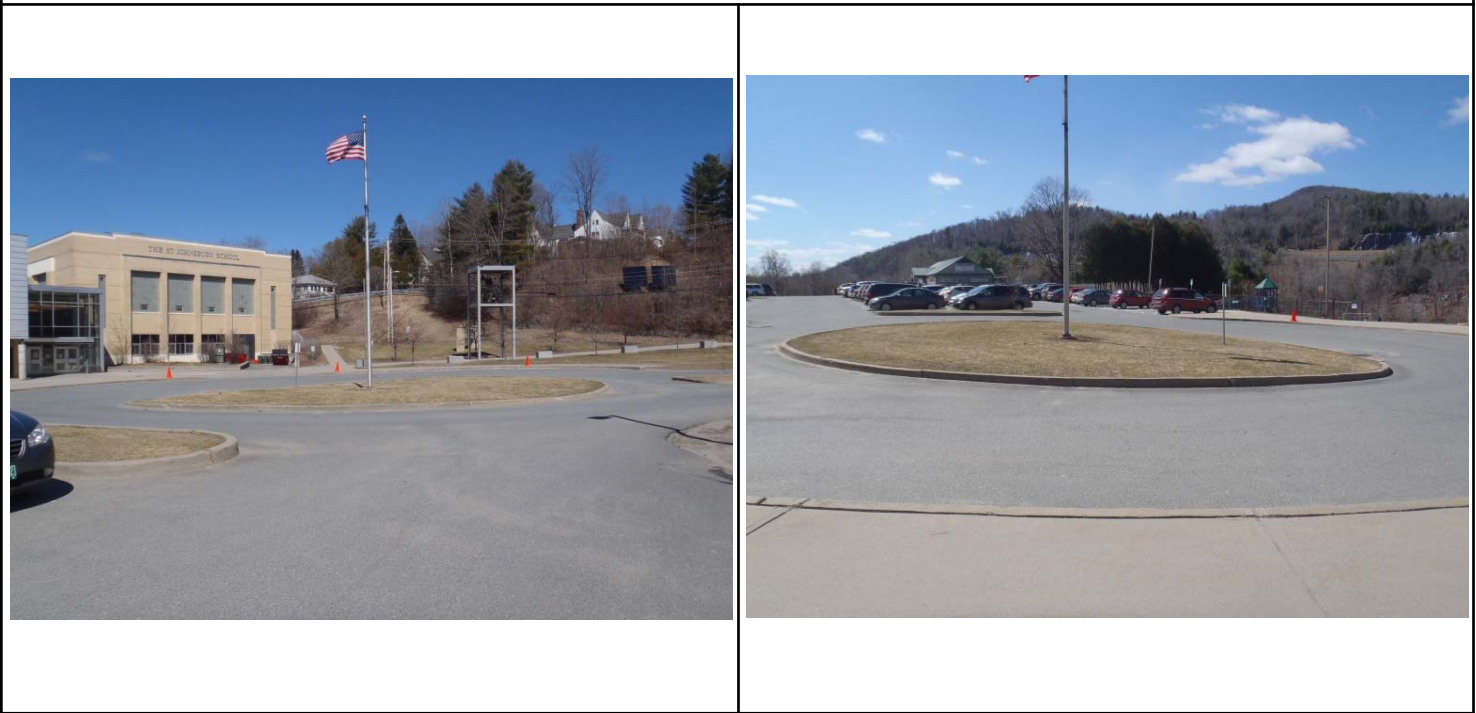
**Description of Observed Conditions:**  
 Retrofit opportunity; Take advantage of existing green around perimeter of upper parking lot and flag circle at School to provide treatment for runoff from the parking lot. There are existing sewer lines in the vicinity of this retrofit opportunity and care will need to be take to avoid potential conflicts.

Photo 1. Flag circle and green space in upper parking lot	Photo 2. Flag circle
---	----------------------

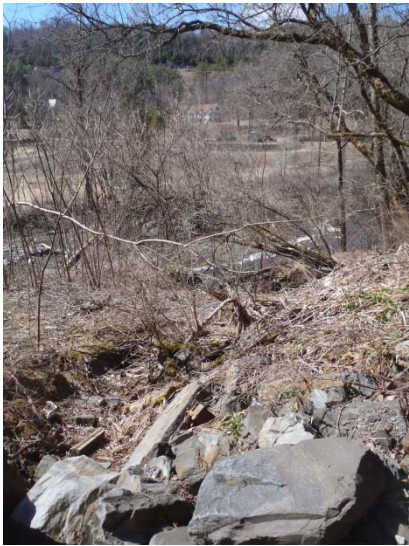
**Description of Observed Conditions:**  
 Runoff from the parking lot is causing gully erosion along steep embankment to the south of the parking lot; in addition to gully stabilization, there may be an opportunity to install a retrofit along the eastern edge of the lot to improve stormwater management.

Photo 1. Looking southward from parking lot at gully

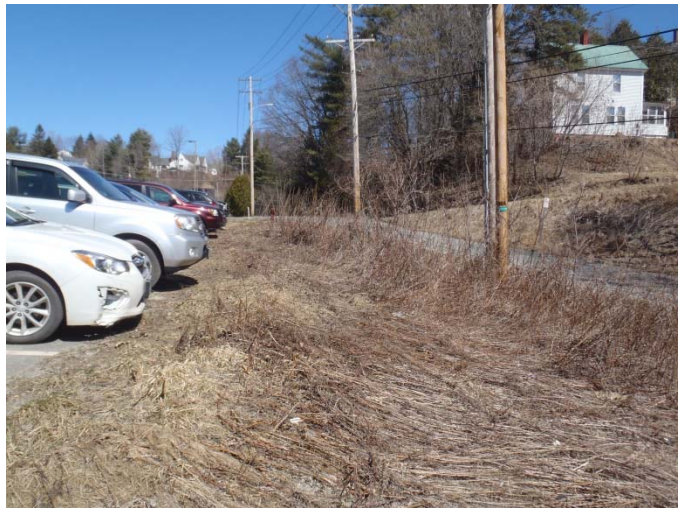
Photo 2. Possible retrofit area east of parking area

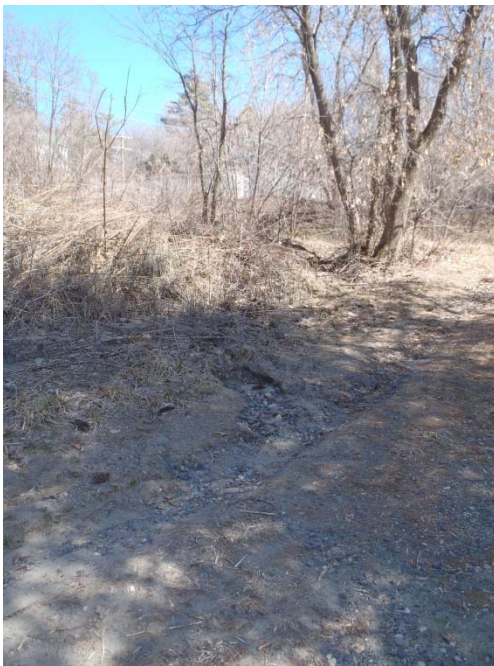
Photo 1. Erosion at western end of Valley St

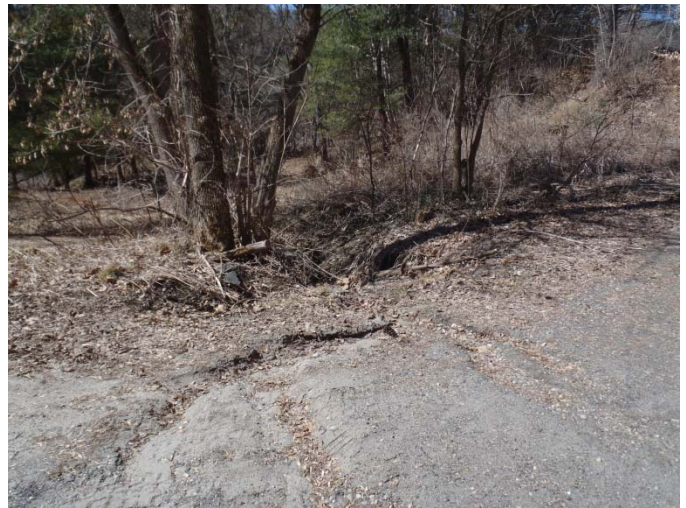
Photo 2. Gully caused by stormwater runoff from SR-03

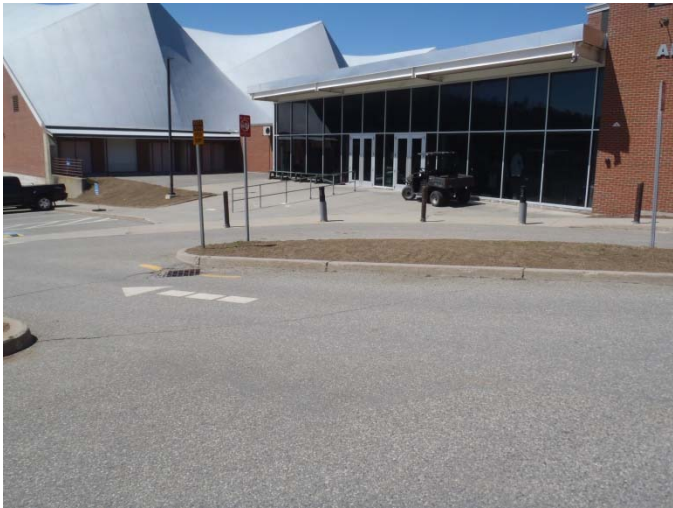
Photo 1. Field house roof and drop-off loop

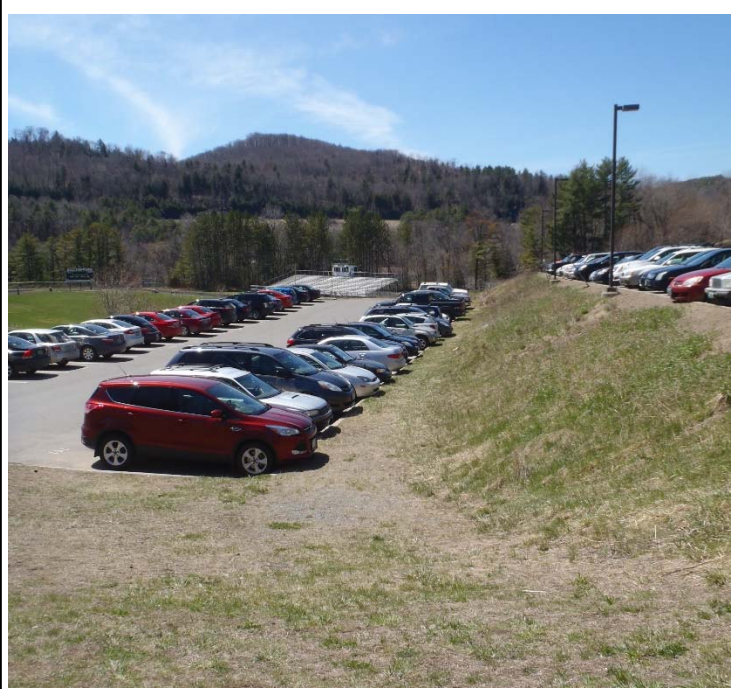
Photo 2. Potential retrofit at “toe” of green space in parking lot

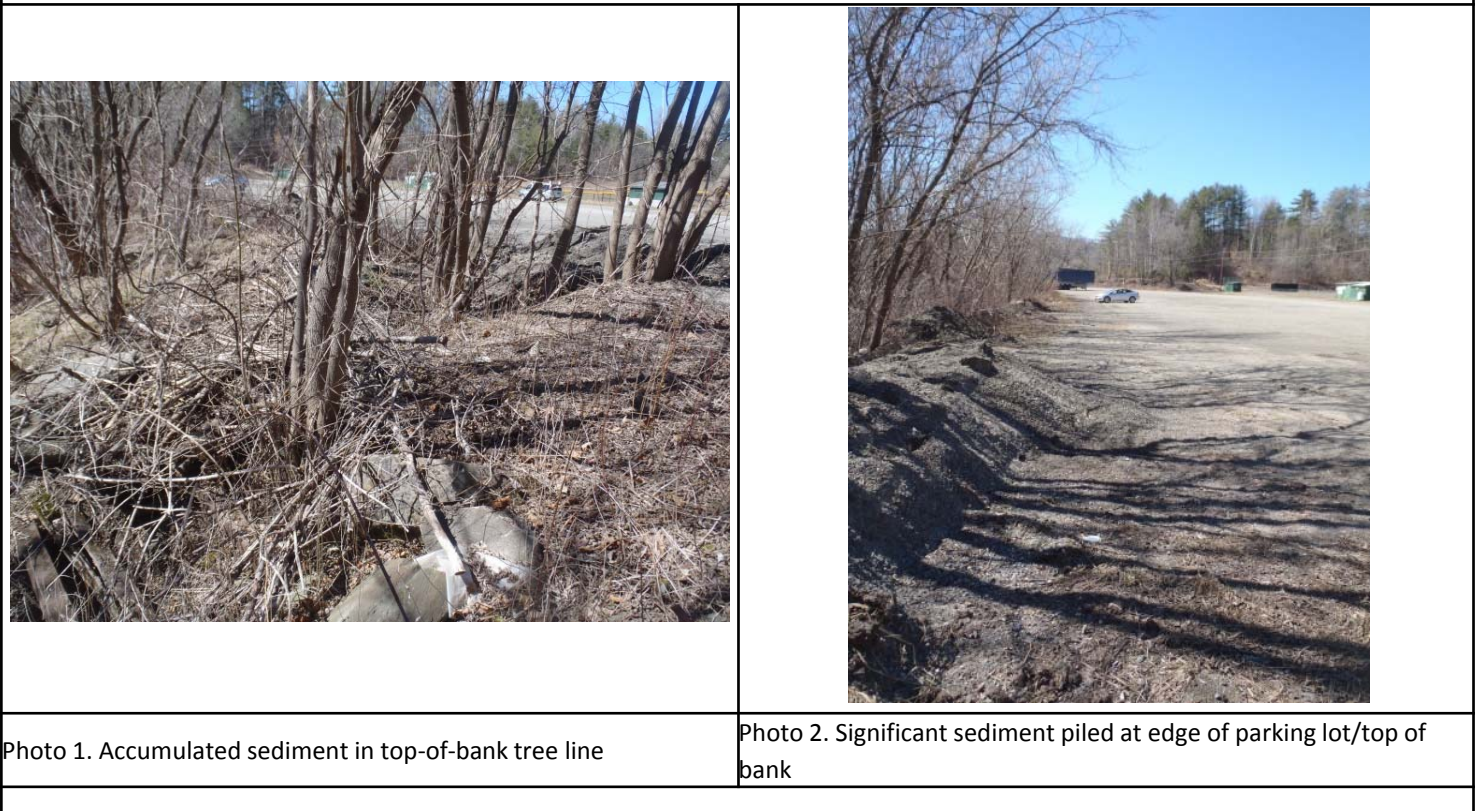
**Description of Observed Conditions:**  
 Almshouse Rd runs through a large gravel parking lot that drains overbank to the Moose River and provides access to the Town Garage and St. Johnsbury Municipal Forest. Some evidence of rill and gully erosion along streambank in areas where concentrated flow leaves the parking lot; during heavier rain events sediment flows down to Concord Ave also into the Moose River.

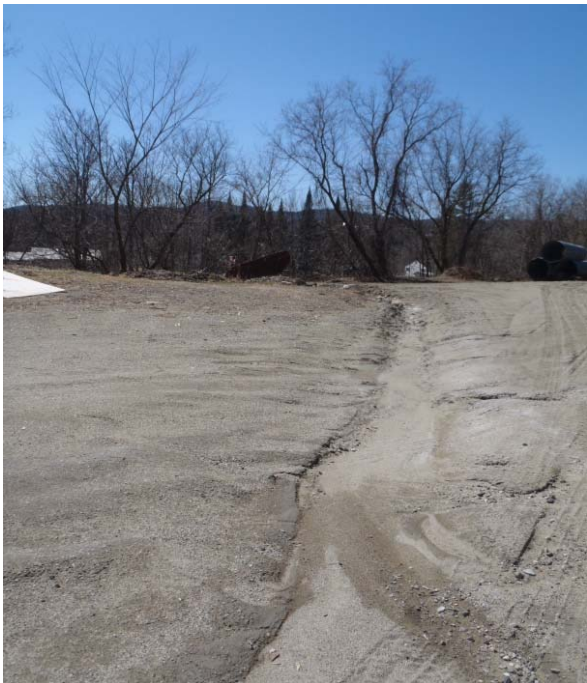
**Description of Observed Conditions:**  
 Sand storage pile at the Town Garage is experiencing “creep” and has slumped over the jersey barriers intended to prevent material from eroding into a nearby drainage swale; both stormwater outlets from the facility show evidence of significant sediment transport and active erosion.

Photo 1. Gully erosion through Town Garage maintenance yard

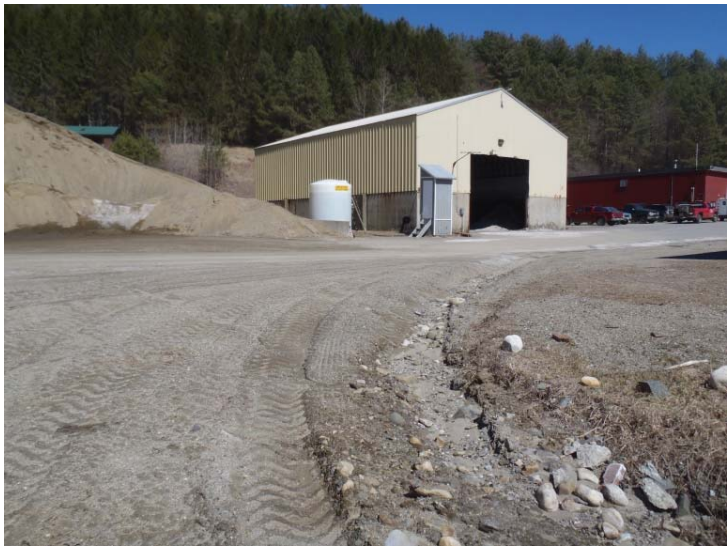
Photo 2. Visible “creep” of the sand storage pile

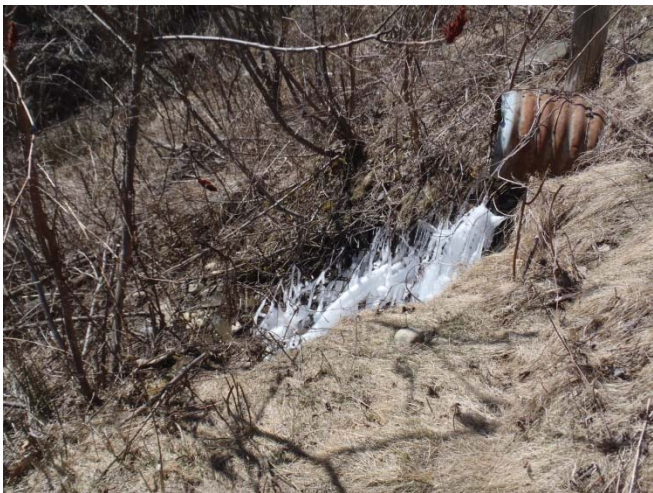
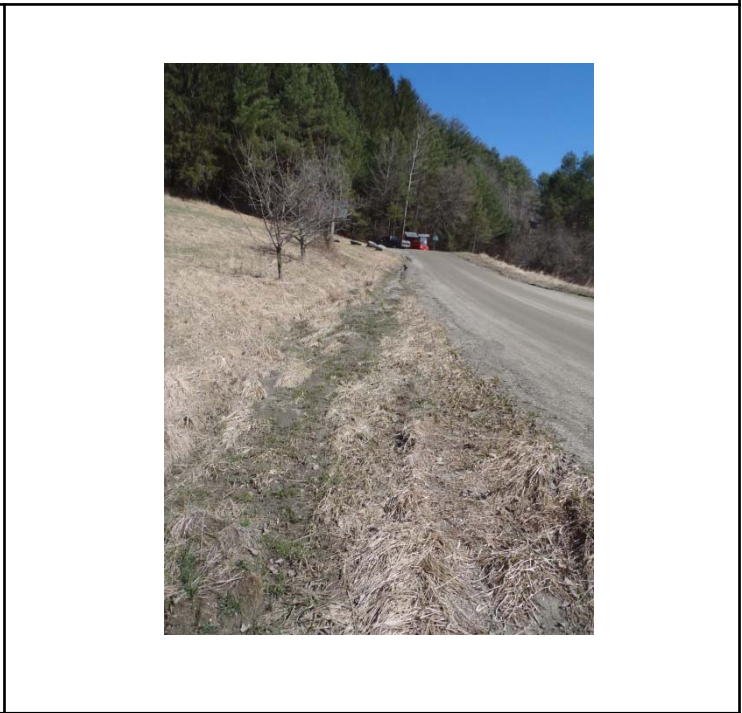
**Description of Observed Conditions:**  
 Visible erosion along the shoulder of the access road; currently at least a portion of runoff from the road and parking area contributes to the problems observed at the Town Garage.

Photo 1. Stormwater outfall from Municipal Forest parking area      Photo 2. Municipal forest access road

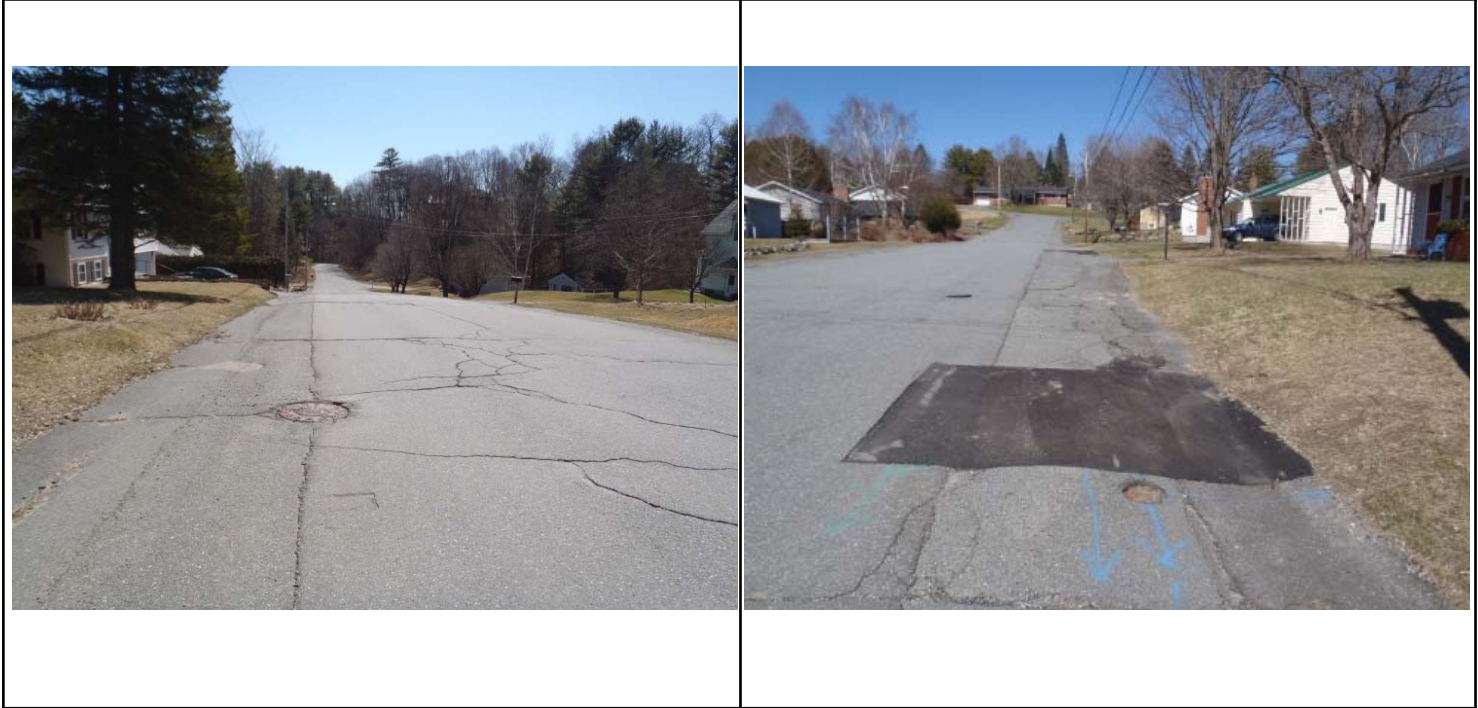
Photo 1. Looking south down Gilman Ave toward Concord Ave	Photo 2. Looking north up Gilman Ave toward Waterman Circ
---	---

**Description of Observed Conditions:**  
 Bring overly-wide section of road back to standard width, establishing a grassed channel with check dams, as needed, on both sides of the road to convey stormwater runoff.

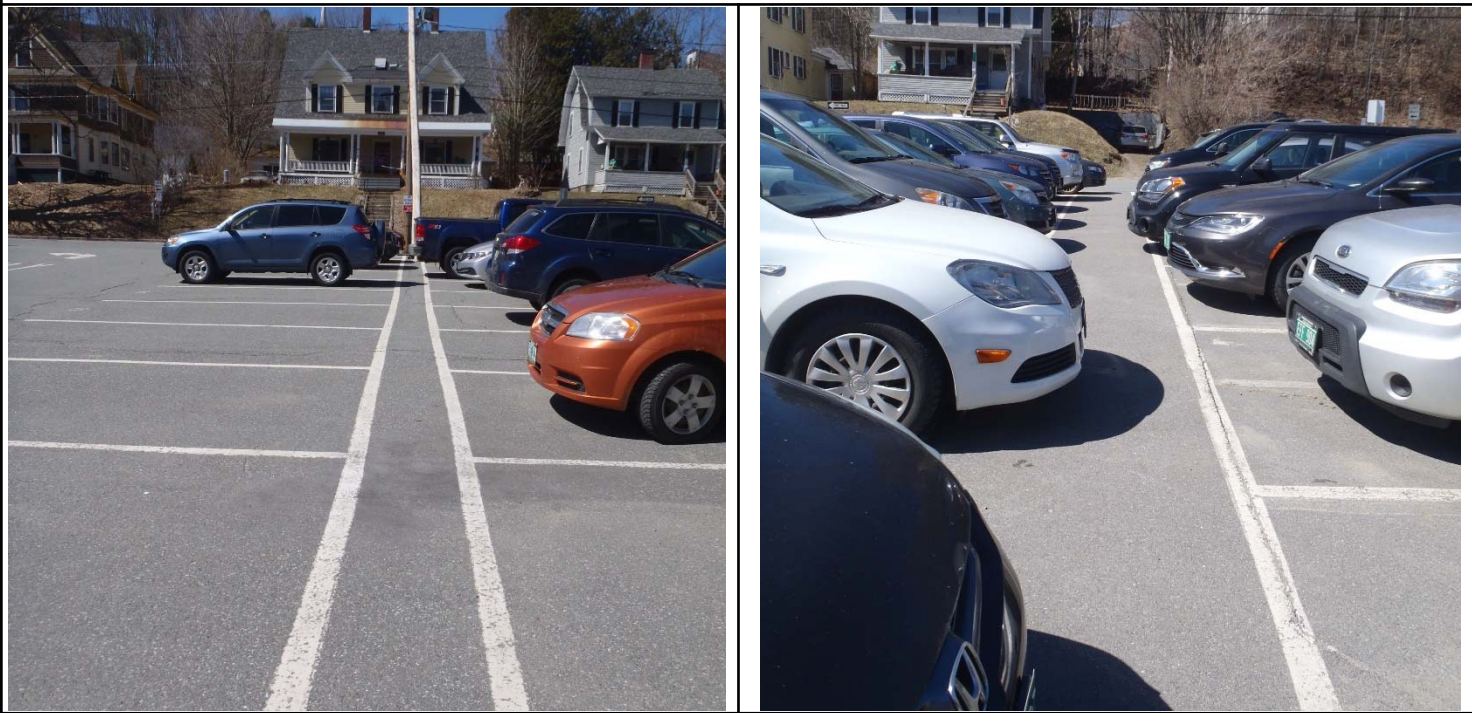
**Description of Observed Conditions:**  
 Significant, unmanaged impervious area. Opportunity to repurpose and recess painted/striped "islands" within the parking lot to intercept and infiltrate stormwater runoff.

Photo 1. Existing "island" in municipal lot      Photo 2. Existing "island" in municipal lot

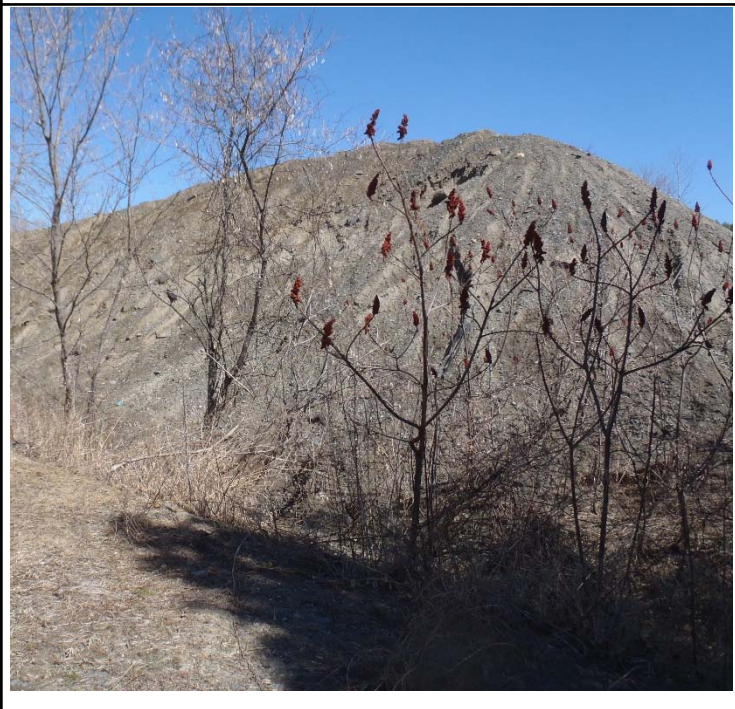
**Description of Observed Conditions:**  
 Large stockpile located in close proximity to the WWTP is actively eroding into a drainage swale; there is evidence of significant sediment transport to the Passumpsic River.

Photo 1. Unmanaged sand pile

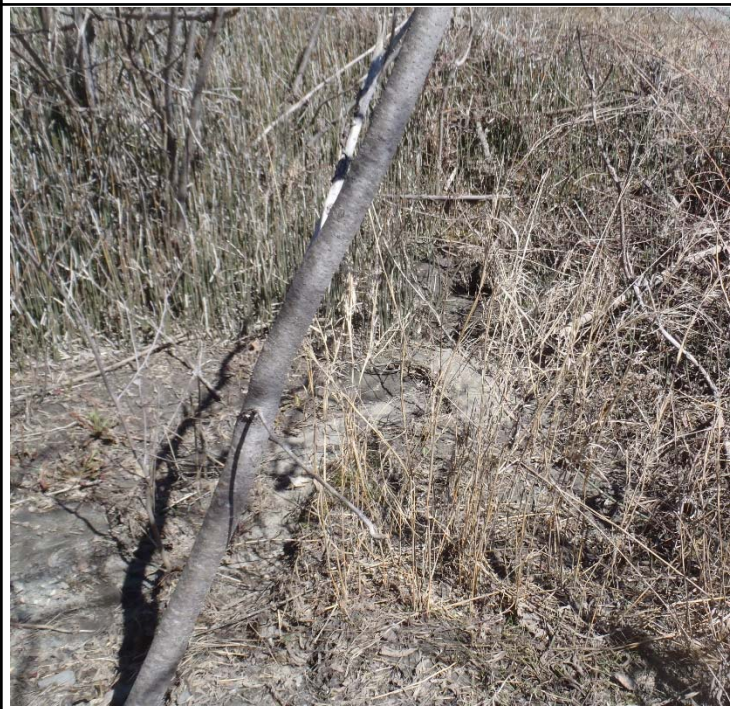
**Description of Observed Conditions:**  
 Heavy sediment load was observed in the swale immediately to the north of 659 Bay St. The swale receives stormwater runoff from the west side of Bay St through a cross-culvert, but the origin of the stormwater is unknown as the infrastructure in this location has not been mapped.

Photo 1: Evidence of sediment deposition at system outfall entering swale on west side of Bay St.

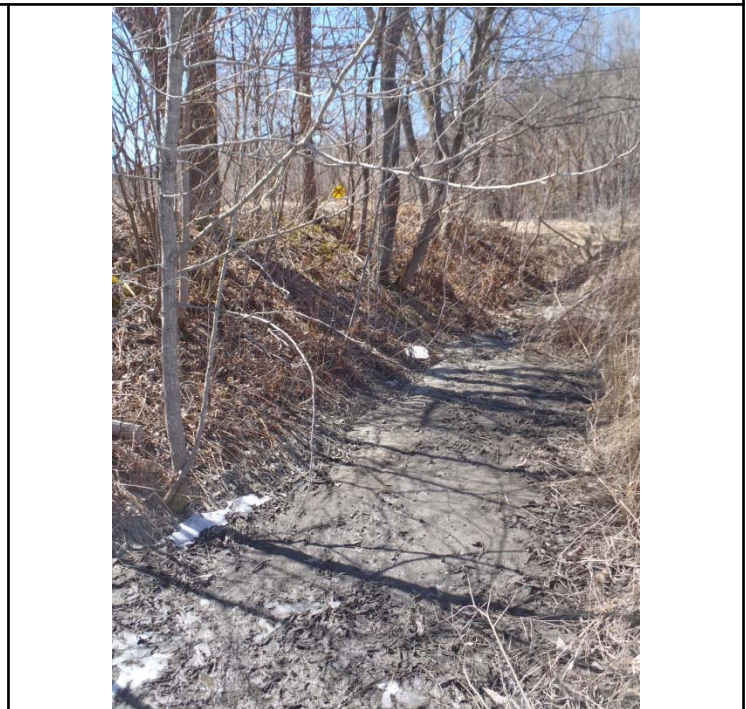
Photo 2. Swale, looking east from Bay St, with sediment deposition

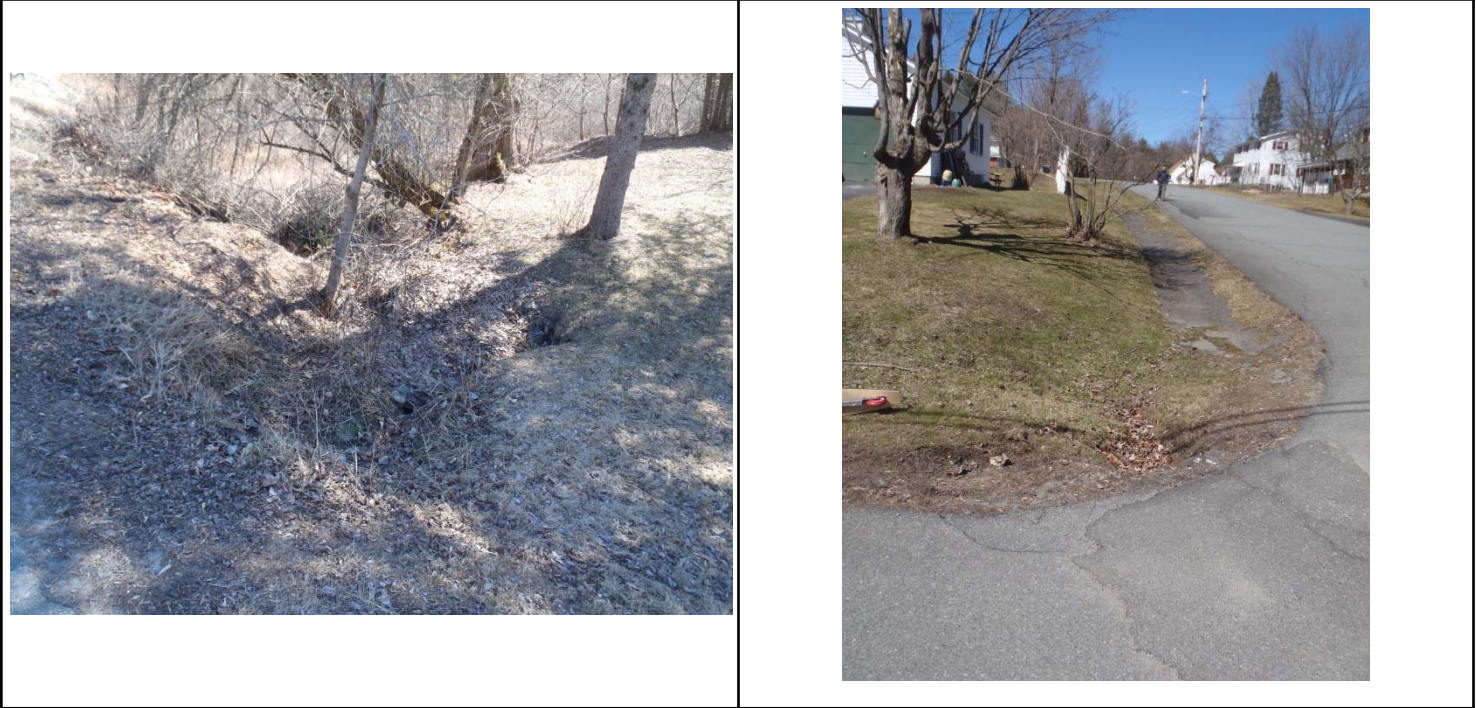
Photo 1: Gully erosion where Farmer Dr crosses unnamed tributary to the Passumpsic	Photo 2. Paved swale along Waterman Circ. at intersection with Farmer Dr.
--	---

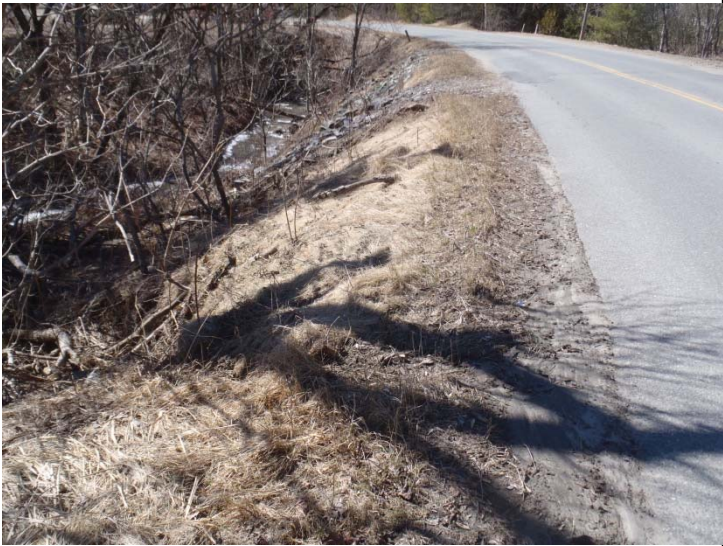
Photo 1: Series of small gullies caused by road runoff

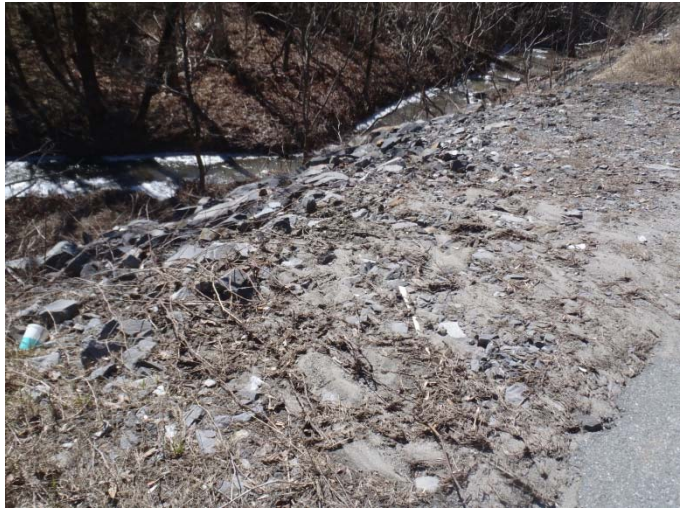
Photo 2: Area of overbank flow and previous stabilization efforts

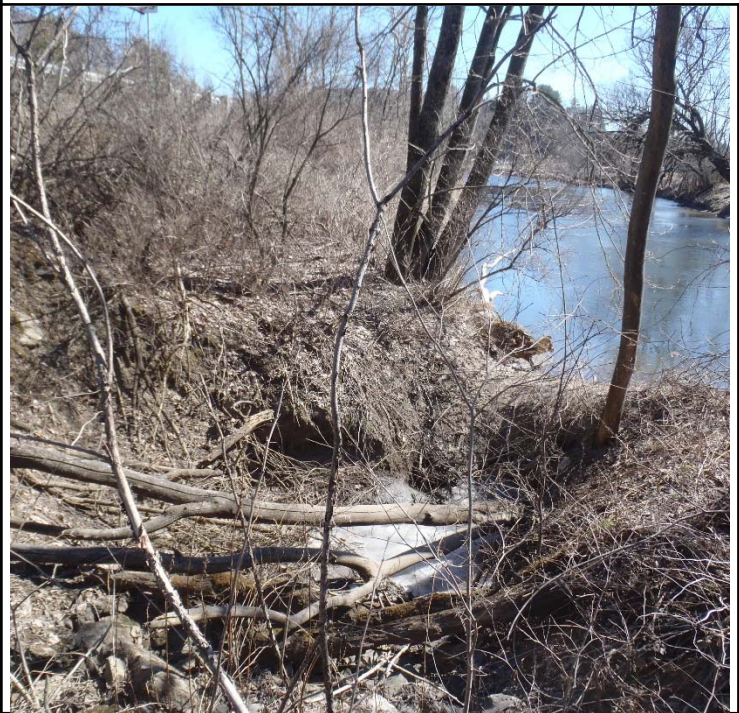
Photo 1: Scour pool at discharge point.

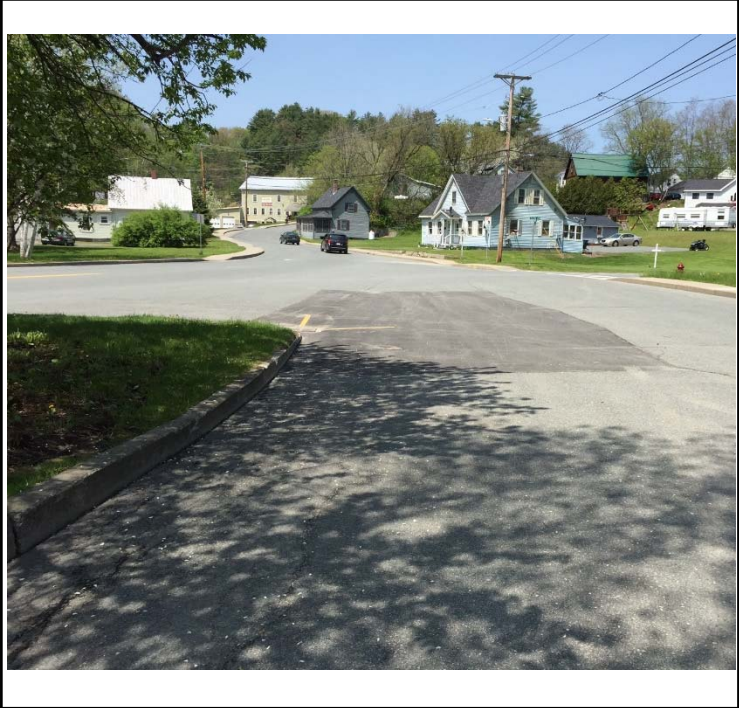
Photo 1: Looking west at intersection of Concord and Old Concord Aves and Gilman Rd.

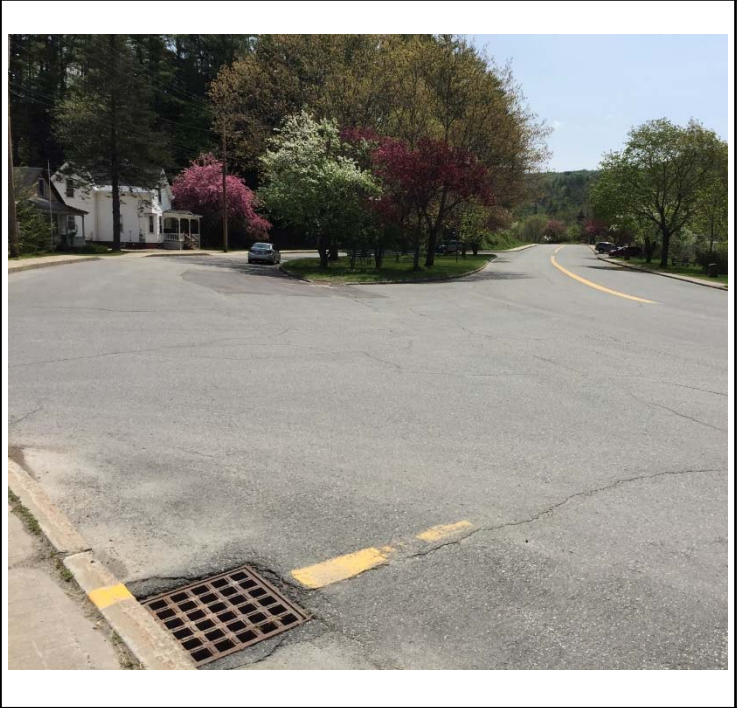
Photo 2. Looking east toward existing green space and overly-wide pavement section
