# Stormwater Master Plan Lyndon, Vermont

August 6, 2018

**Fitzgerald Environmental Associates, LLC.**  
18 Severance Green, Suite 203  
Colchester, VT 05446

**Caledonia County Natural  
Resources Conservation District**  
481 Summer Street, Suite 202  
St. Johnsbury, VT 05819

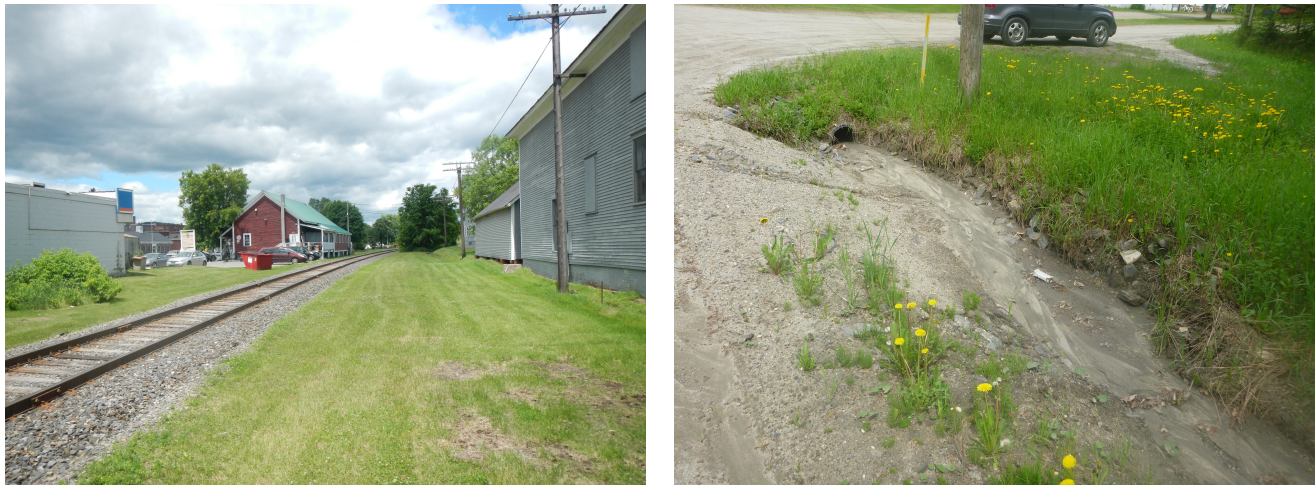
**Figure 2:** A stormwater pipe carrying runoff from portions of Williams Street to a stable grassed swale infiltration area had the lowest score (Rt5-9). Severe road erosion and large volumes of sediment along Lily Pond Road (LY-8) had the highest problem area score.

6. **Project LY-8:** – The ditch along the east side of the road is badly eroded and is sending large volumes of sediment into the adjacent intermittent stream. The cross-culvert outlet is unstable and has a large gully along the road edge.

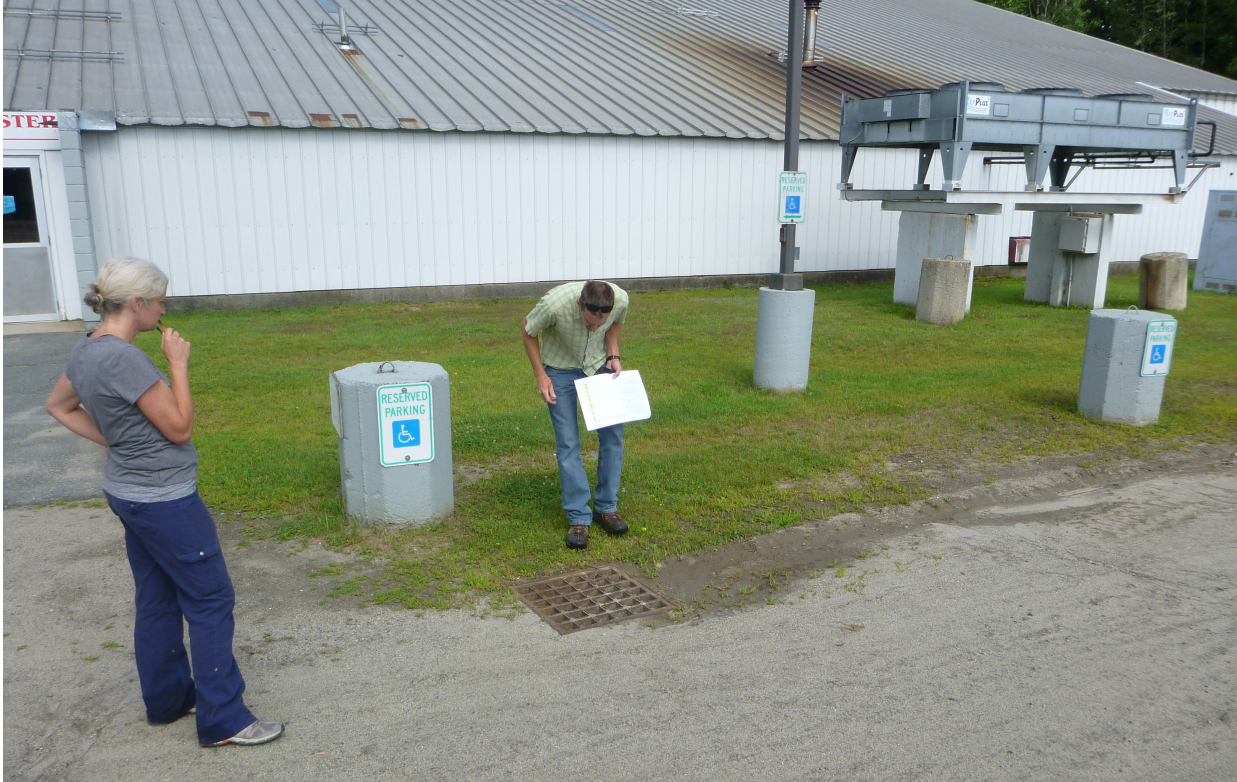
**Figure 4:** Evan Fitzgerald (FEA) and Kerry O'Brien (CCNRCD) assessing catch basin retrofit options at the Fenton-Chester arena (Project LI-7).

1. **Project LI-6 & LI-7: Lyndon Institute Fenton Chester Arena & Softball Fields Parking Area** – The 1.4-acre gravel parking lot drains south and is diverted into a water bar that empties into a narrow strip of vegetation along the top of the steep valley wall leading to the stream. Sediment is trapped in the vegetation; however, no additional treatment or slope stabilization measures are in place. A small but active gully was observed along the top of the steep slope. Erosion is also visible along the western edge of the parking lot and a large volume of sediment is delivered to a catch basin in front of the arena, which is piped directly to the stream (Figure 4).

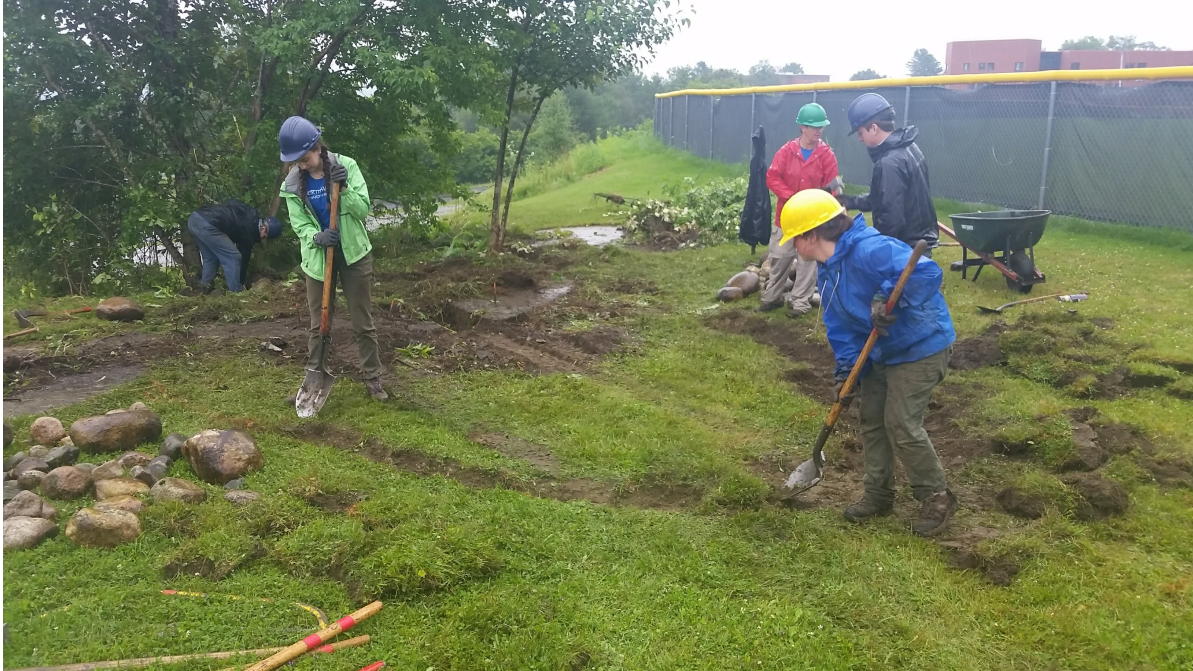
**Figure 5:** NorthWoods crew beginning site work for the LSC-6 project.

4. **Project LSC-6: Lyndon State College Baseball Fields** – A mowed grassed swale between the two baseball fields collects runoff from a portion of the fields and adjacent grassed areas, draining to an existing low point at the top of the steep bank before spilling over into an armored swale down the steep bank. Nutrient loads from this drainage area likely very high.

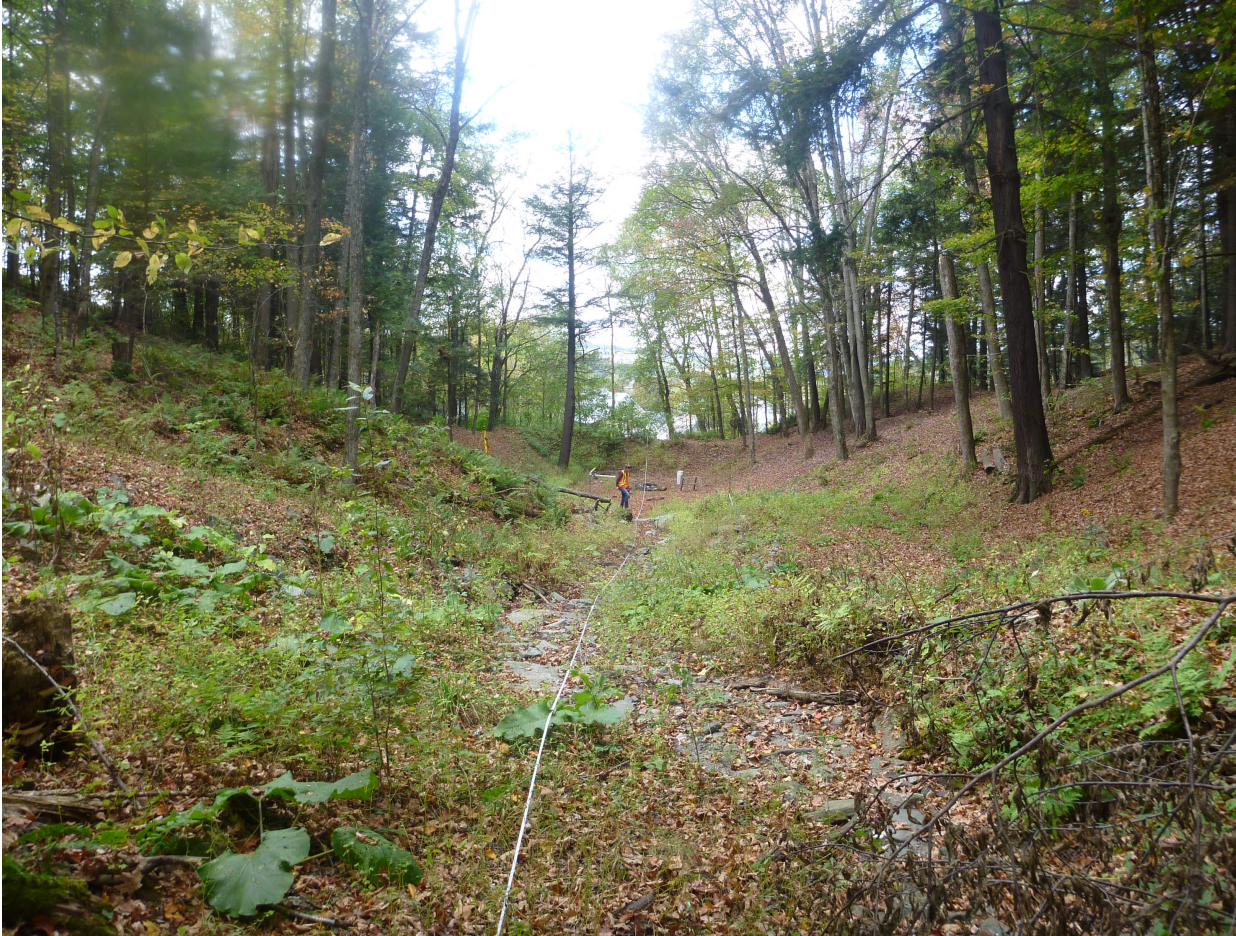
**Figure 6:** Longitudinal survey collection through the existing sediment basin for Project LY-13.

1. **Project LY-13: High Street Extended Detention Basin** – Three catch basins draining steep sections of Chase Street, High Street, and Pinehurst Street drain to a settling pond. Significant erosion is visible along the flow path from the Pinehurst outfall. The pond outlet is too low and stone armor at the inlet is insufficient.
2. **Project LSC-7: Lyndon State College Faculty and Staff Parking Lot** – Runoff from the baseball fields through the swale described in LSC-6 and from a catch basin near the concession stand flow down an armored swale to a grassed swale along the southern end of the parking lot. Nutrient loads are very high from this drainage. The southern portion of the parking lot also drains to this area. The culvert under College Road is in poor condition.
