APPENDIX F:

Design-Build Plans for High Priority Stormwater Mitigation Sites

Project LI-1: Lyndon Institute Maintenance Building Swale

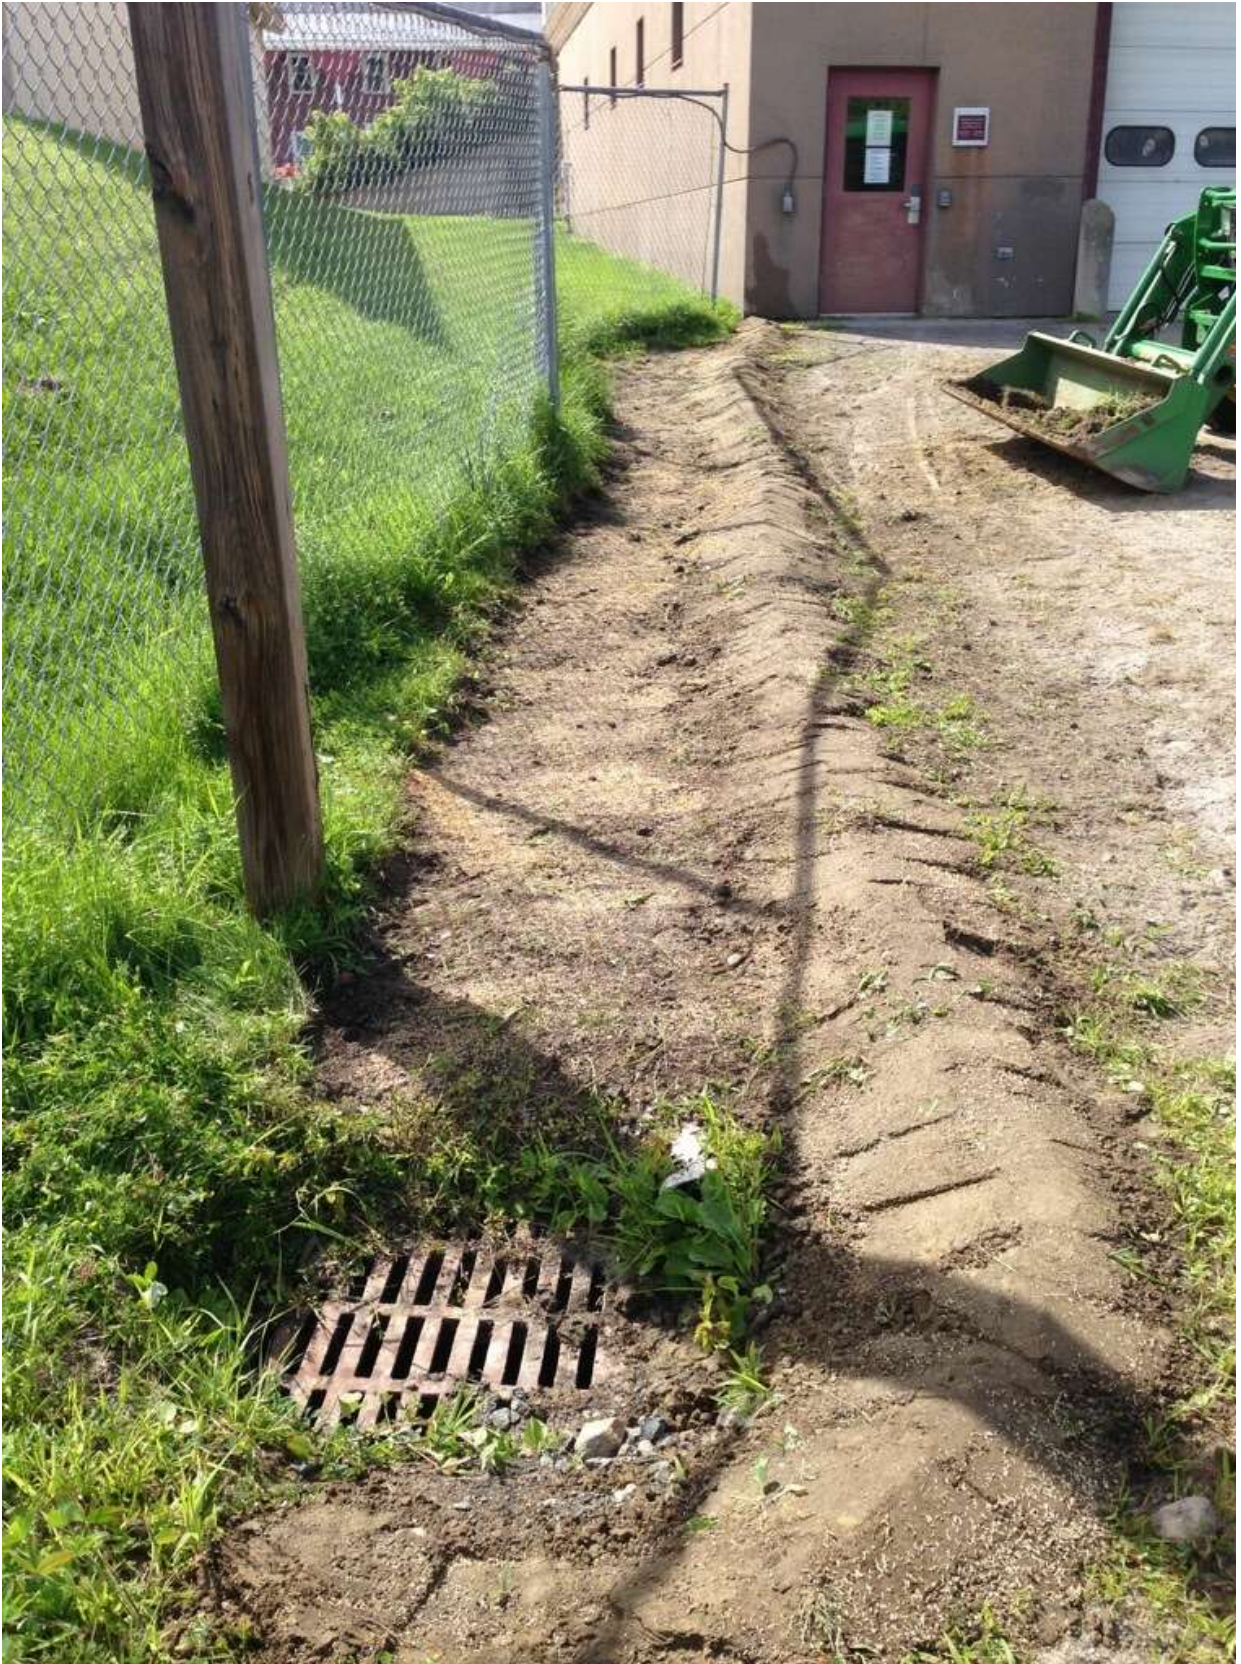
The project was completed in July 2017 by the NorthWoods Stewardship Center crew (Figure 2). The drain pipe was a significant design constraint requiring the final swale to be defined primarily by a berm, instead of through an excavated flow path. Rock was added to stabilize the drop to the catch basin and the swale was seeded and mulched.

Figure 2: A small swale created to convey clean water from the rooftops to the existing catch basin.

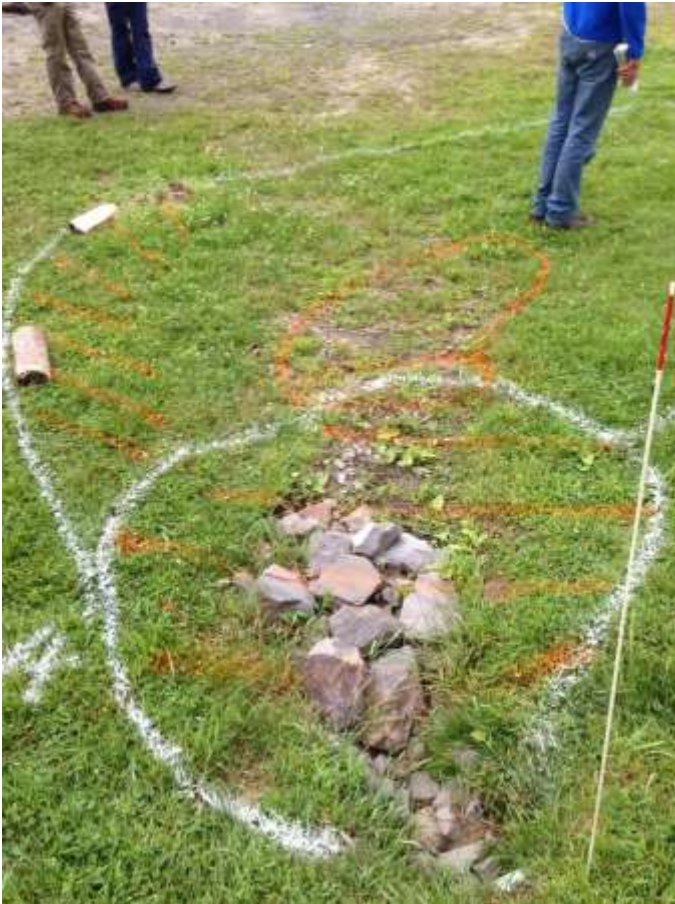
Figure 4: Pre-construction site layout

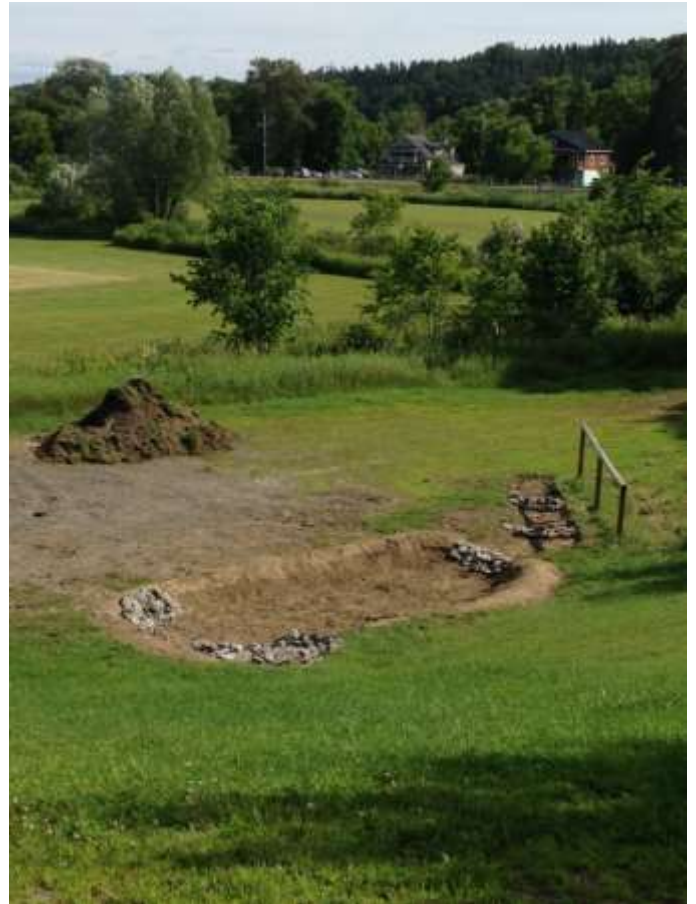
The project was completed in July 2017 by the NorthWoods Stewardship Center crew (Figure 5). FEA and CCNRCD conducted a follow-up visit on 8/31/2017 and noted additional improvements required to stabilize the sediment basin. The splash apron stone lining was not thick enough and was causing erosion

Figure 5: Constructed sediment basin

of the underlying soil around and under the rock. Additional rock was recommended for the edge of the basin near the inlet. Northwoods completed the site improvements in November 2017.

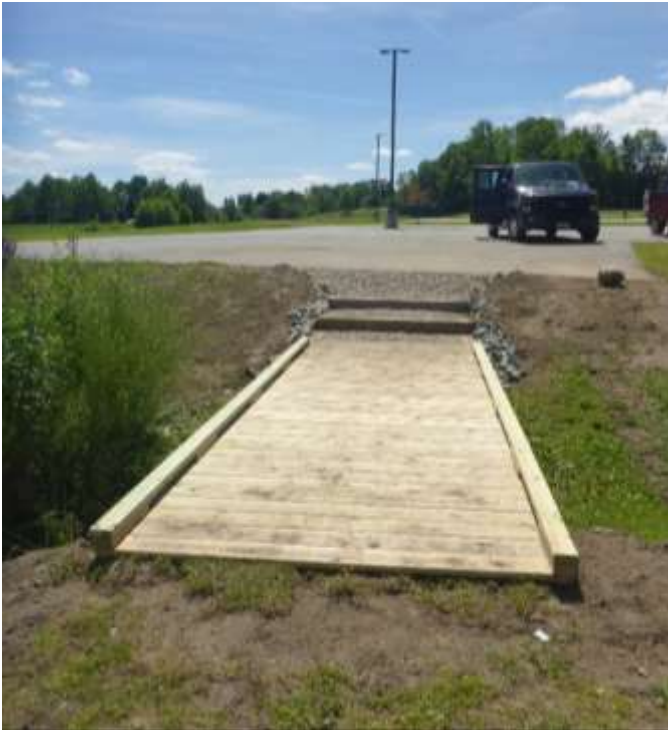
The project was completed in July 2017 by the NorthWoods Stewardship Center crew (Figures 7 and 8). FEA and CCNRCD conducted a follow-up visit on 8/31/2017 and noted minor areas of exposed soil. LSC agreed to hydroseed the site as needed.

Figure 7: Footpath bridge over the stormwater swale

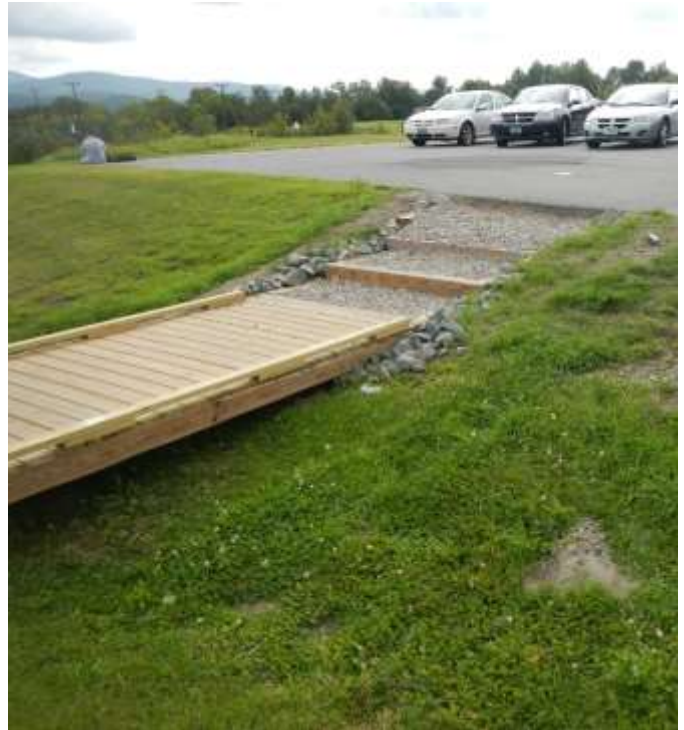
Figure 8: Infiltration steps between the bridge and parking lot

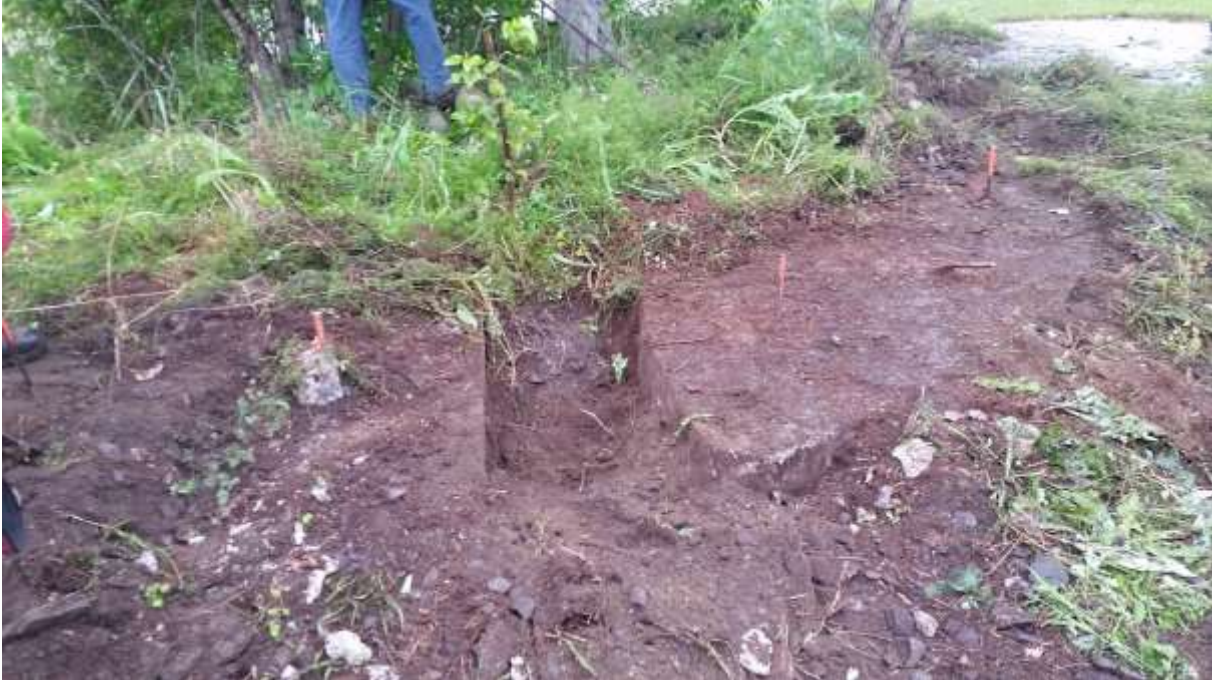
The project was completed in July 2017 by the NorthWoods Stewardship Center crew. The basin was hand dug by the crew and the finished depth was approximately 2.5ft, limited by a layer of hardpan clay underlying the site. The NorthWoods crew uncovered a concrete ring located at the BMP outlet. An existing notch in the ring provided an ideal outlet structure for the rain garden (Figure 10). FEA and CCNRCD conducted a follow-up visit on 8/31/2017 and noted minor areas of exposed soil (Figure 11). LSC agreed to hydroseed the site as needed.

Figure 10: Concrete ring uncovered during excavation

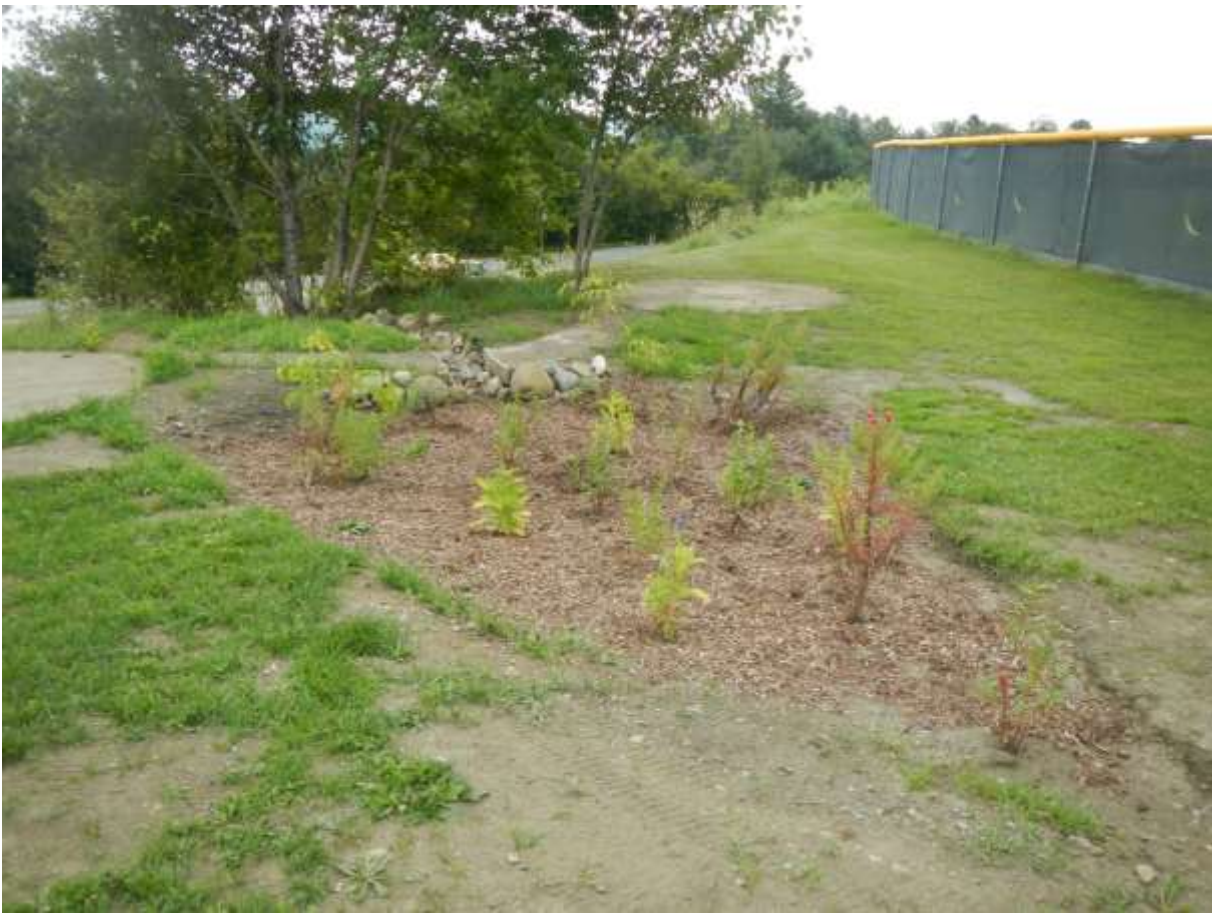
Figure 11: Completed rain garden with some exposed soil from construction disturbance
