## Stormwater Master Plan Town of Hardwick, Vermont

This project was performed by Stone Environmental, Inc. for the Caledonia County NRCD with funding provided by the Vermont Department of Environmental Conservation – Ecosystem Restoration Program.

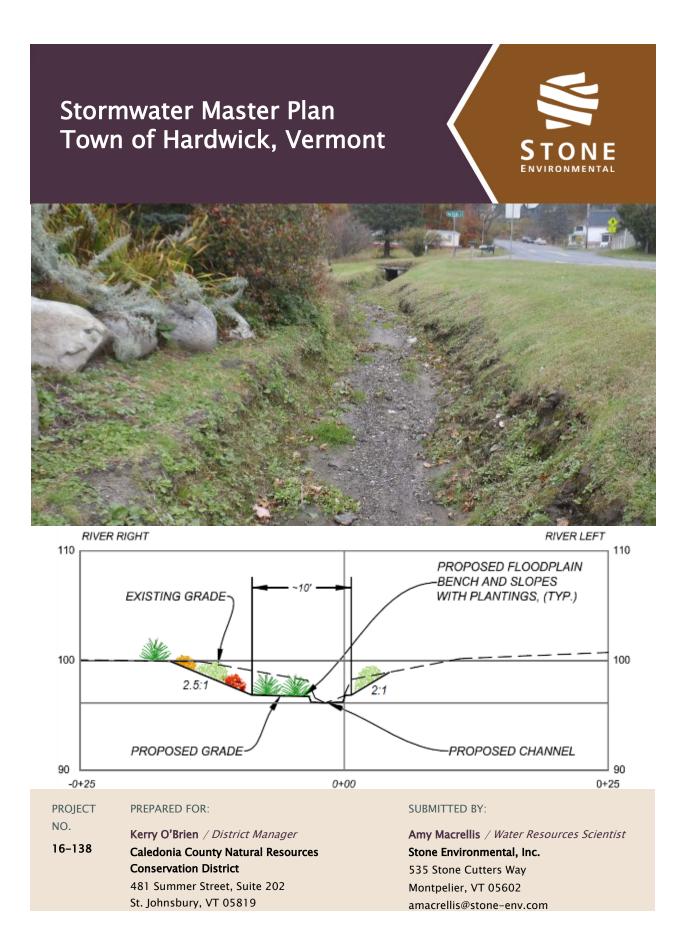
Cover: Present condition of a roadside channel adjacent to **Buffalo Storage** and VT Rte. 14 (top), and concept plan for a natural channel design to address the site's erosion and sediment transport issues (bottom).

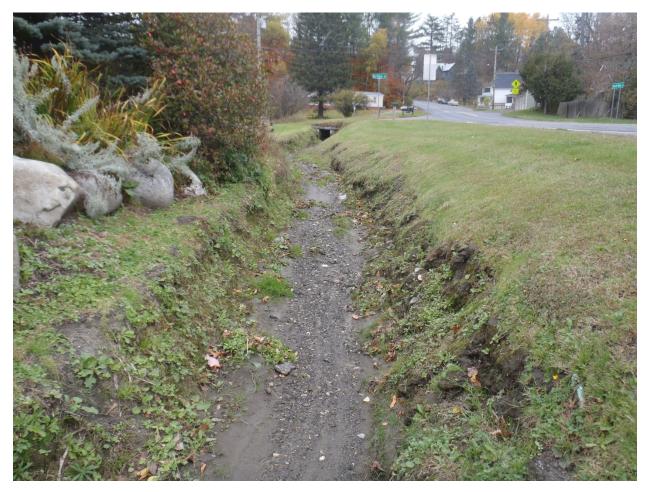
The Buffalo Storage site includes a first order unnamed tributary to Cooper Brook that runs generally north to south, parallel to Route 14, and directly adjacent to the Buffalo Storage facility (see CB-05 PADS in Appendix B, and conceptual design plans in Appendix D). The existing channel is essentially serving as a drainage ditch that conveys roughly 111 acres of drainage from lands that have been steadily developed over time. The channel is actively transporting large sediment loads directly to Cooper Brook. This portion of the channel is also subject to regular ditching and re-shaping by either the Town or VTrans, roughly once every 2-4 years. It is suspected that the channel is in adjustment due to the increased impervious area upstream, meaning that the channel is adjusting its cross sectional area to accommodate the increase in flows and stream power conveyed during storm events. The severity of sediment transport and active erosion can be observed in the photo below.

For conceptual design at this site, Stone considered Schumm's Channel Evolution Model (CEM; USDA 2012). The CEM provides a predictable sequence of changes a stream can undergo after disturbances such as channel straightening, increase in peak discharges, or decrease in sediment load (see figure in Appendix D). The changes can include increases or decreases in the

width/depth ratio of the channel and alterations in the floodplain (USDA 2012). Field investigations performed by Stone indicate that the channel is currently in stage II, where the channel is incising and not reaching its floodplains during large storm events. Stream power is being expended on erosion of the channel bed and banks during these events.

The proposed restoration is based on accelerating the channel evolution process and bringing the channel to stage V of the CEM, where a new 'inset' floodplain exists and channel bed and banks have re-stabilized. Restoration includes a revised stream channel sized to accommodate the 1.5 year storm event, floodplain benches to accommodate flows for larger storm events (i.e. the 2 through 100 year events), side slopes graded between 2:1 and 3:1 up to existing grade, and planting of native vegetation along benches and slopes. Also proposed is a pool and step on the upstream end to serve as a sediment forebay, and upsizing of the downstream existing culvert. The end result is lower channel velocities, higher channel roughness, less sediment transport, a significant increase in channel conveyance and increased storm resiliency during storm events. It is estimated that restoration will contribute to a total suspended solids load reduction of 47,130 lbs./year and a phosphorus load reduction of 47.1 lbs/yr.
