APPENDIX D:

**One-Page Summary Sheets for
Stormwater Problem Areas**

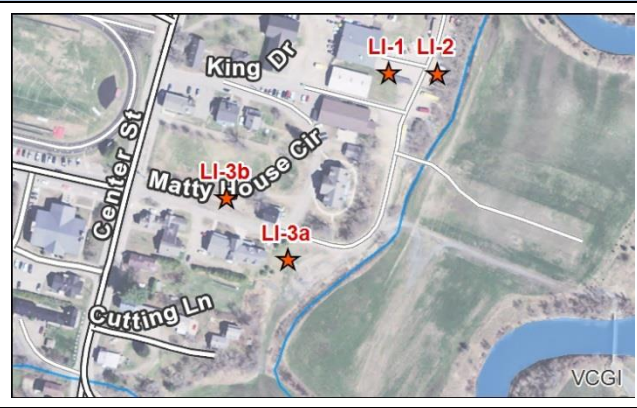
Site Description: Three gullies have formed along the steep bank at the edge of the parking area. Winter plowing has altered the grading so runoff does not drain to the armored swale.

Additional Project Benefits Description: The gullies are an ongoing source of sediment and nutrient loading to the stream; seasonal high water could further increase erosion of the loose sediment along the bank.

BMP Description: Excavate the loose soil and plowing materials along the edge of the parking lot and install an armored spillway, grade the edge of the parking lot to direct all flow to armored spillways, and create a winter plowing plan to minimize future gully formation.

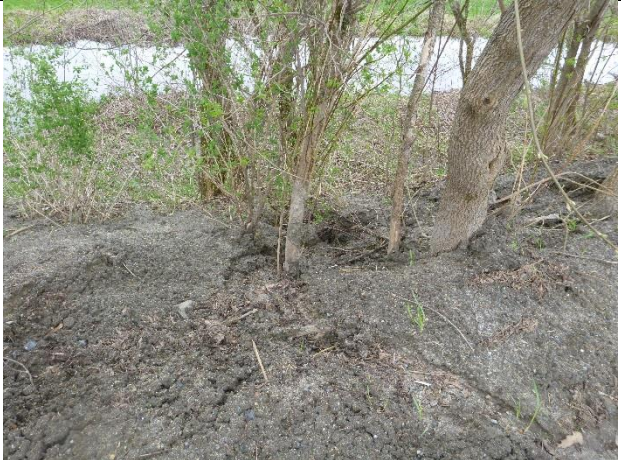
Photo 1: Gully erosion through plow deposits and the steep bank down to the stream.

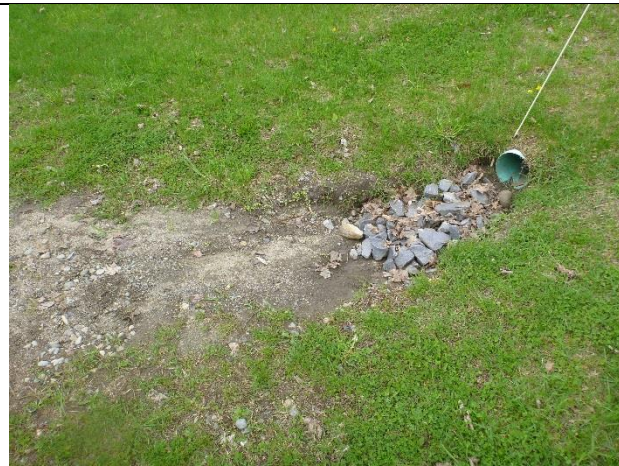
Site Description: A stormwater pipe draining an area of paved roads and unpaved parking and fire lane with associated compacted soils discharges to an overflow parking area for the soccer fields along the Passumpsic River. High velocity flows from the steep stormwater pipe are causing additional erosion across the lower parking area before draining directly in to the adjacent stream.

Photo 1: Erosion at the pipe outlet

BMP Description: Excavate the existing compacted soils and Install a grass-lined sediment trap along the edge of the parking area. Install a large rock check dam and a splash apron at the culvert outlet to diffuse the high velocity flow and protect against scour. The sediment trap should be sized to store the WQv storm. The sediment trap will overflow through a second rock check dam in to a grass-lined swale. **This project was completed in July 2017 by a Northwoods Stewardship Center work crew.**

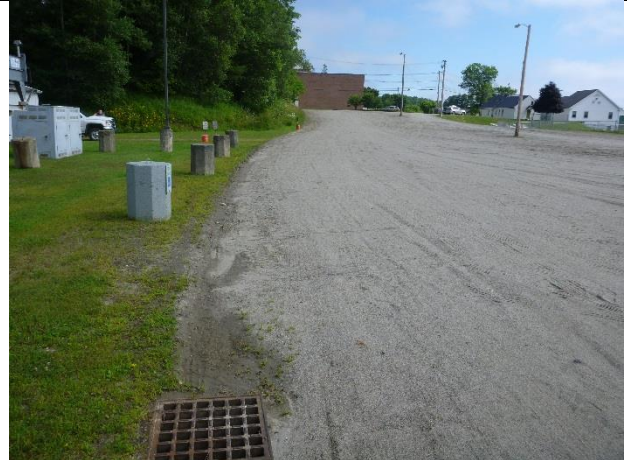
Site Description: Erosion is visible along the western edge of the parking lot and a large volume of sediment is delivered to a catchbasin in front of the arena, which is piped directly to the stream.

Photo 1: Flow path along the edge of the large gravel parking lot draining into a catchbasin.

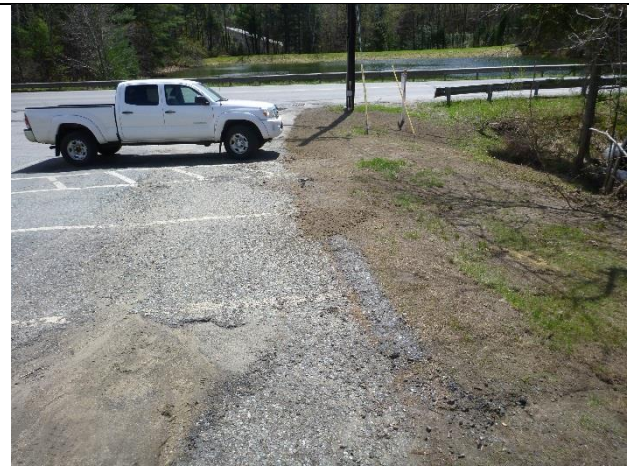
Site Description: The large paved parking area and a portion of College Rd drain to a catch basin that is piped directly in to Institute Pond. Runoff from portions of the parking area flow along the edge of the pavement causing erosion along the grassed area. Some runoff continues directly down the steep slope in to the pond.

Photo 1: Catchbasin located at the Institute Circle and College Road intersection, drains to the pond.

Photo 2: Sheetflow over exposed soil along the steep bank to the pond.

BMP Description: Repair the broken curb to prevent runoff from eroding along the edge of pavement. Establish vegetation along the bank. The catchbasin should be inspected and will likely require more frequent cleanout.

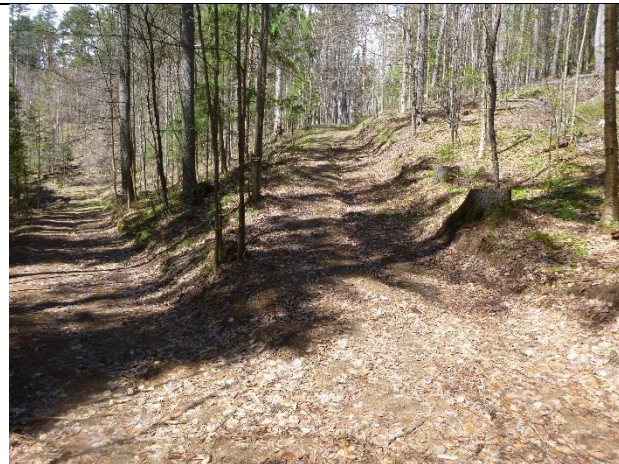
Photo 1: Minor erosion at a trail junction.

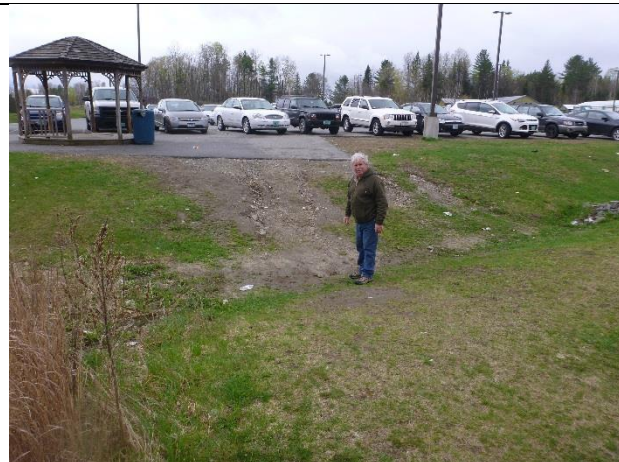
Site Description: A footpath across the swale leading to the dry detention basin is compacted and has bare soil with active erosion. Portions of the parking lot drain directly to this path and vegetation will be hard to establish due to foot traffic. Excess sediment from this site is likely reducing the effectiveness of the existing BMP.

Photo 1: Erosion and compacted soils on footpath through swale at the BMP.

BMP Description: Install a footbridge across the swale and create a defined walking path with a stone and/or hedge border. Till compacted soil and establish vegetation. Boxed infiltration steps will reduce runoff from the parking lot. **This project was completed in July 2017 by a Northwoods Stewardship Center work crew.**

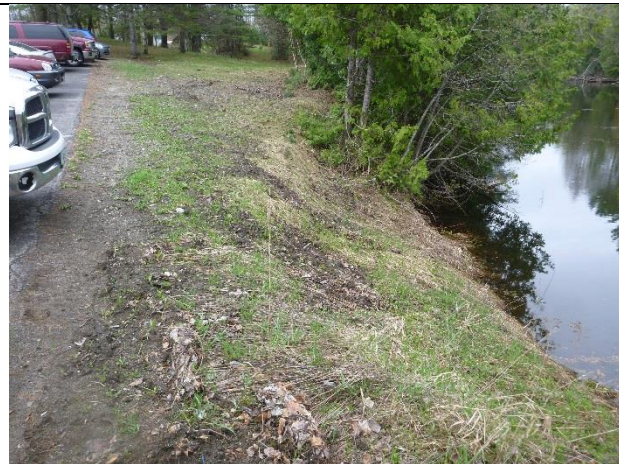
Site Description: Runoff from McGoff Hill is causing erosion along the road edges and flows directly in to Dragon Pond near the outlet. Winter plowing along the road and parking lot is likely a significant sediment source to the pond.

Photo 1: Erosion along the edge of pavement and the steep bank leading to the pond.

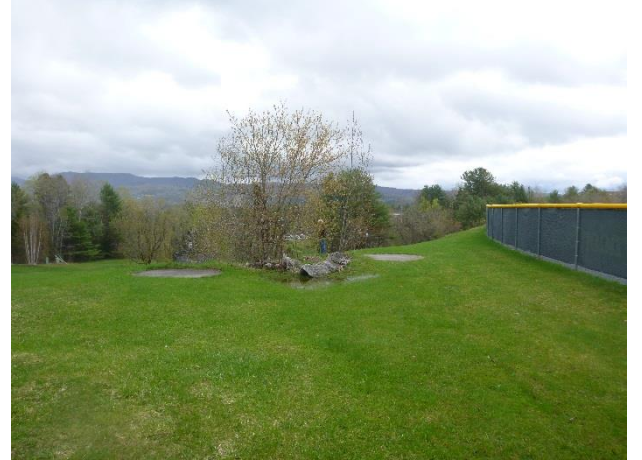
Photo 1: Existing low point at proposed rain garden location.

Photo 2: Swale between the two baseball fields.

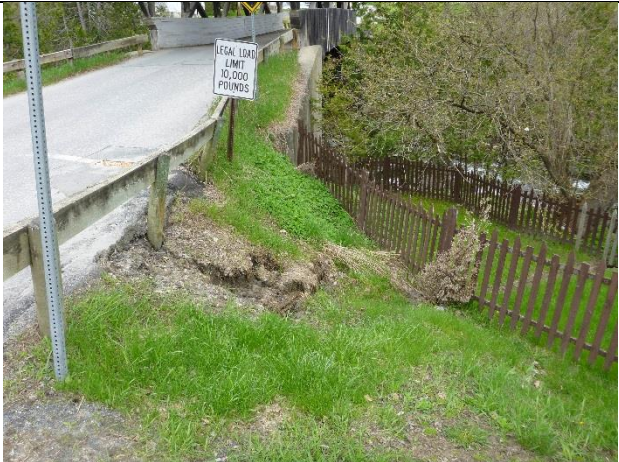
Photo 1: Gully erosion through embankment and yard to Wheelock Brook.

Additional Project Benefits Description: The recent pavement repairs and the ongoing gully erosion show that this is a chronic problem area. The gully erosion is beginning to undercut the guardrail and the edge of the pavement.

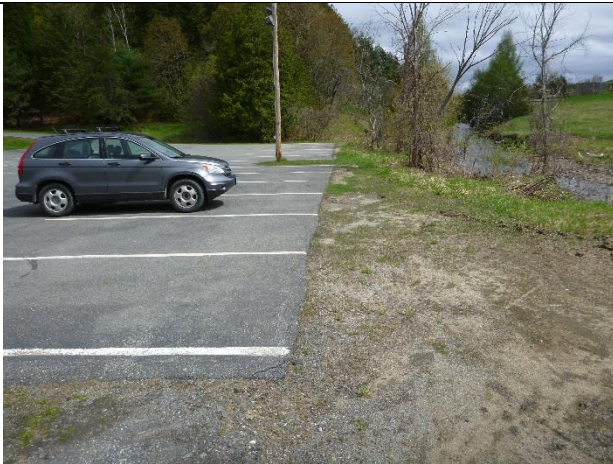
Site Description: Runoff from the lower parking area sheetflows directly in to Wheelock Brook. Two small gullies have formed in areas of concentrated runoff. Winter plowing appears to push snow off of the east edge of the lot, directly into the stream and adjacent floodplain.

Photo 1: Parking lot draining directly to Wheelock Brook.

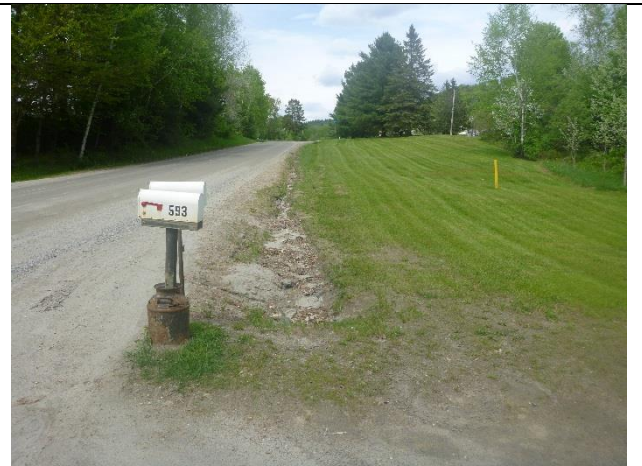
Site Description: The ditch along the east side of the road is badly eroded and is sending large volumes of sediment into the adjacent intermittent stream. Several areas of gully erosion along the road edge upslope. The cross-culvert outlet is unstable and has a large gully along the road edge.

Photo 1: Gully erosion and significant sediment loads in ditch.

Photo 2: Long ditch section along a moderately steep section of Lily Pond Rd.

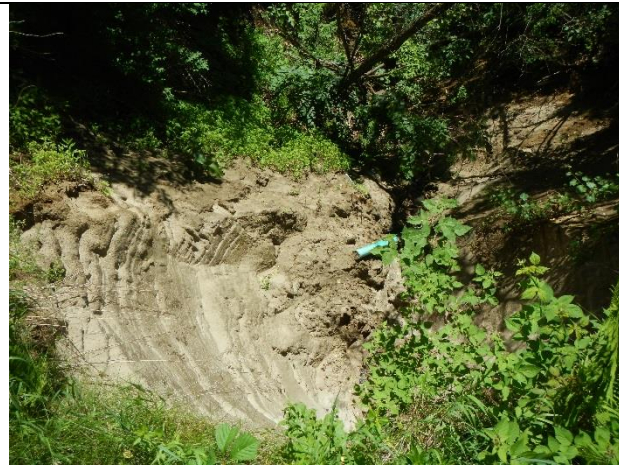
Site Description: A very large and steep gully has formed along the steep valley wall. No obvious concentrated flow paths lead to the gully, a stormwater pipe outlet 4' from the top may be increasing erosion.

Photo 1: View from the top of the gully.

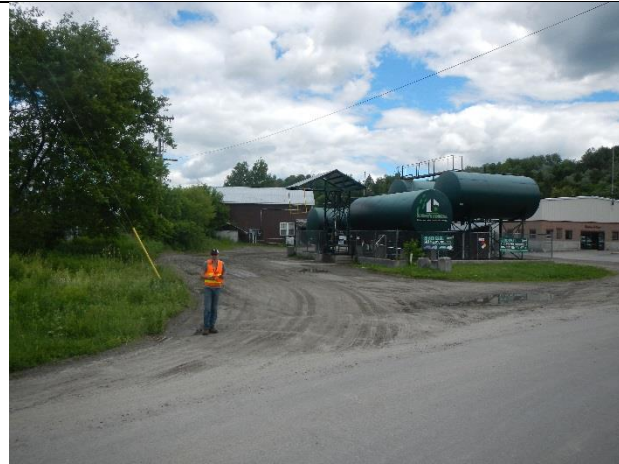
Site Description: A large industrial complex with dirt parking areas partially drains to the southwest corner of the property near the train tracks. Runoff currently flows into a series of catchbasins which appear non-functioning. Stormwater infrastructure is not fully mapped, it is unclear where the runoff goes.

Photo 1: Location for potential BMP.

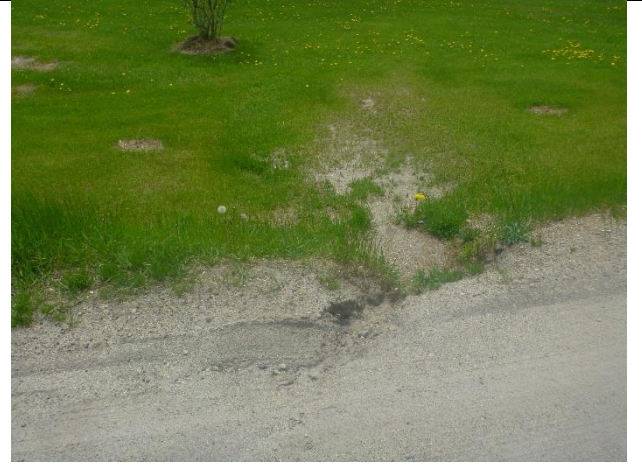
Site Description: Huge volumes of sediment are deposited on the lawn adjacent to an intermittent stream channel. Sediment is coming from two different culvert outlets and from gully erosion along the road edge. Additional erosion was observed at the inlet and outlet of the stream culvert under Strawberry Hill Rd.

Photo 1: Large sediment deposits along intermittent stream off of Strawberry Hill.

Photo 2: Large gully along road edge with sediment deposits in floodplain.

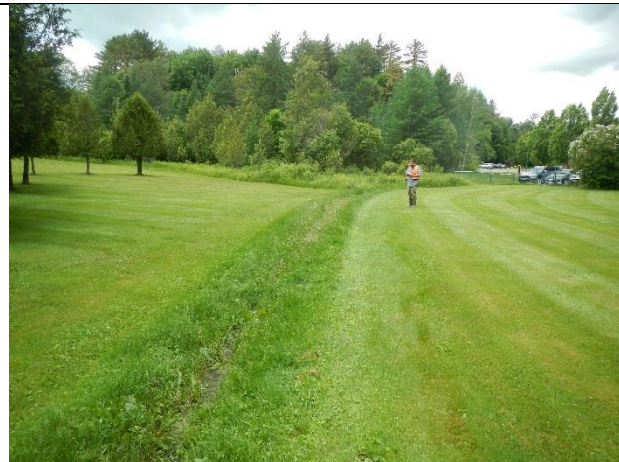
Site Description: A ditch through the lawn area carries flow out of the wetland connecting to the roadside ditch. Portions of the roof and parking lots drain to the wetland. The wetland appears to be functioning well upslope of the ditch.

Photo 1: Ditch leaving the wetland and flowing towards Lily Pond Road.

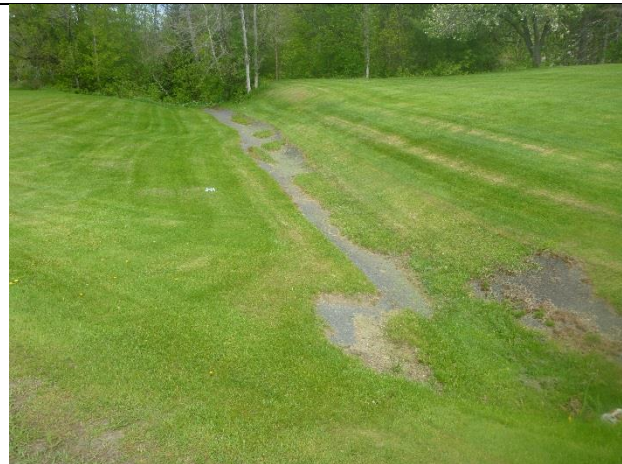
Site Description: An asphalt lined ditch carries runoff from a large portion of the Lyndon Town School property and portions of Lily Pond Road. The ditch spills down a steep bank into the stream with areas of moderate erosion and a small gully.

Photo 1: Asphalt ditch carrying runoff from the Lyndon Town School and Lily Pond Road.

BMP Description: Install a linear treatment feature to infiltrate stormwater and trap sediment and stabilize the outlet channel down to the stream.

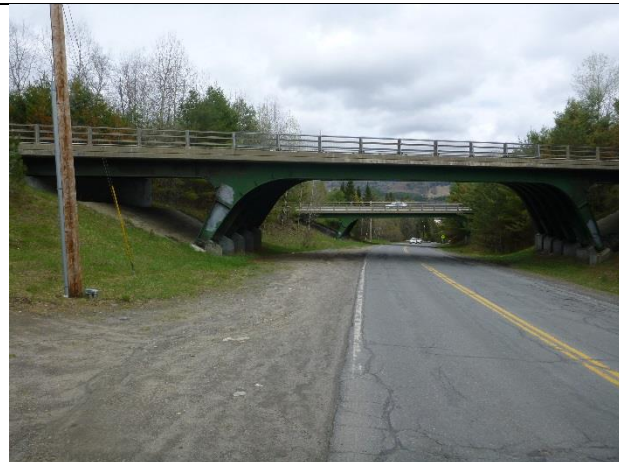
Site Description: The north side of the road lacks a defined ditch and surface runoff is causing moderate to severe erosion of the road shoulder. Two turnouts are only partially accessible leading to increased flow along the edge of the pavement. Some runoff and sediment is reaching Institute Pond.

Photo 1: Poorly defined ditch with bare soil and active erosion.

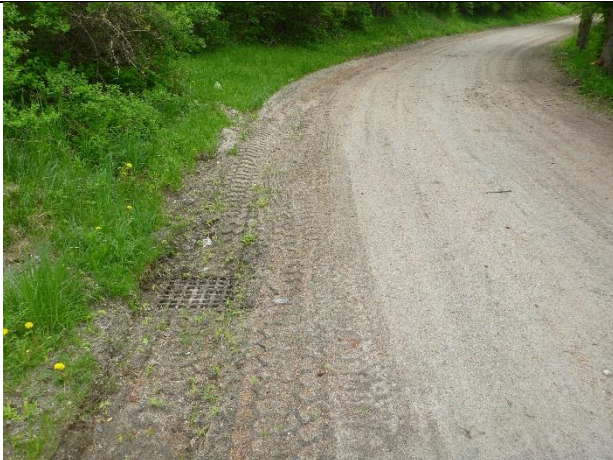
Site Description: Steep road segment with erosion and no ditches. Steep drop to cross-culvert inlet has gully erosion. Storm drain directly connected to intermittent stream draining to wetland.

Photo 1: No ditch along steep section of road draining to a drop inlet.

BMP Description: Install a stone lined ditch to trap sediment upslope of the storm drain.

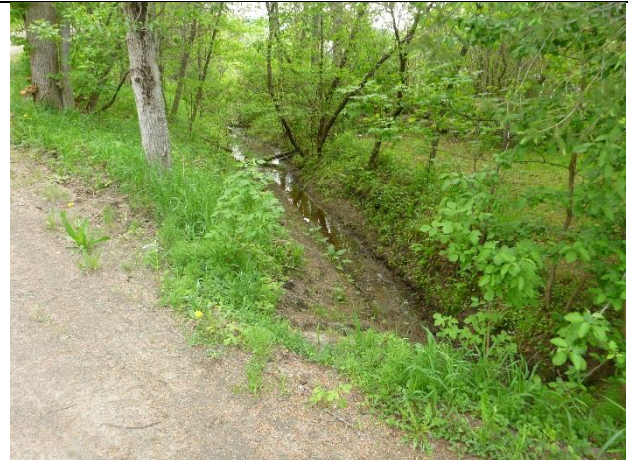
Photo 2: Stormwater cross under road to intermittent stream flowing into a wetland.

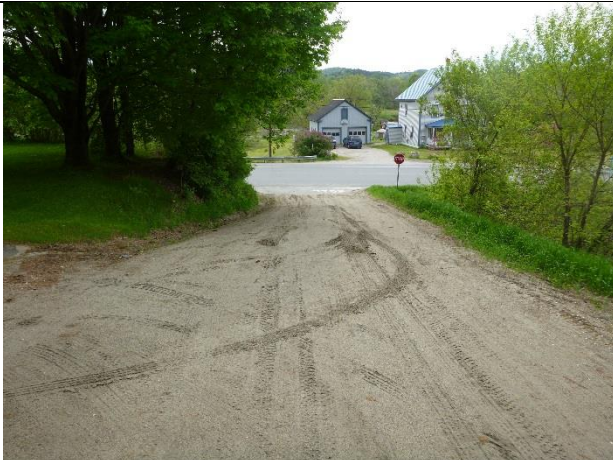
Site Description: Steep road segment with erosion and no ditches. Stormwater flows across road and empties in to wetland to the southwest. Town appears to have made a temporary sediment trap in the wetland.

Photo 1: Steep road segment with no ditches, grader berm on south side.

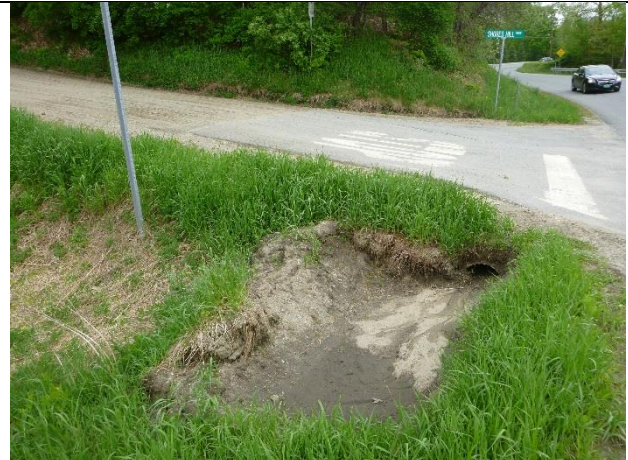
Photo 2: Sediment trap at base of hill in wetland.

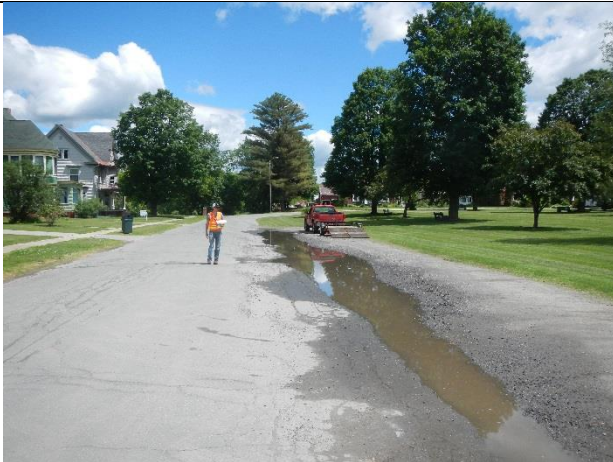
Site Description: Unpaved parking area for the park is eroding. Low point along the edge of the road receives runoff from park and road, draining to a catchbasin on Maple St.

Photo 1: Low point between road and gravel parking area conveys runoff to the south.

BMP Description: Grade the site to encourage flow into a gravel swale and install a small BMP at the corner of the park. An overflow outlet can tie in to the existing catch basin. **Highway Department installed catchbasins tied in to Maple St in August/September 2017 to improve site drainage – BMP implementation is unlikely following this work.**

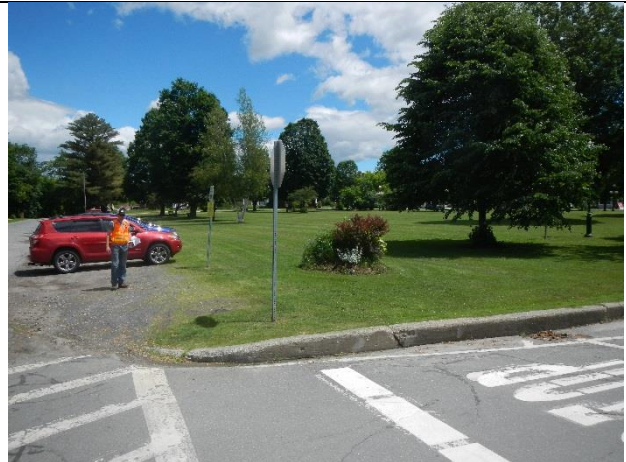
Photo 2: Possible location for BMP near existing flower plantings.
