# Stormwater Master Plan Town of St. Johnsbury, Vermont

PROJECT NO.

15-215

Cover:  
Illustrative  
concept design  
for a portion of  
the Oak Street  
drainage area  
before (top) and  
after (bottom)  
implementation  
of green  
infrastructure  
practices.

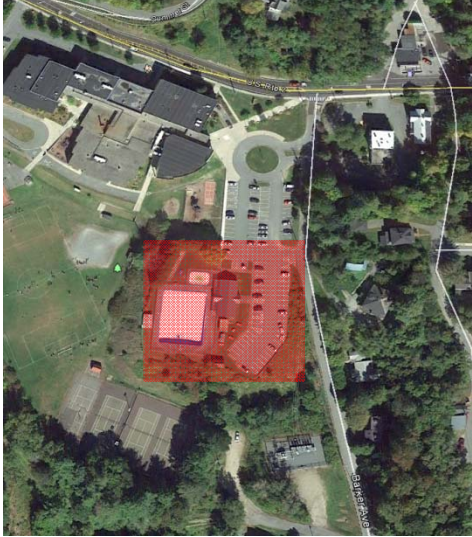
<b>Problem Area ID:</b> SR-03	<b>Latitude:</b> 44.245575	<b>Longitude:</b> -72.012948
<b>Watershed:</b> <hr/> Sleepers River

**Description of Observed Conditions:**  
 Runoff from the parking lot is causing gully erosion along steep embankment to the south of the parking lot; in addition to gully stabilization, there may be an opportunity to install a retrofit along the eastern edge of the lot to improve stormwater management.

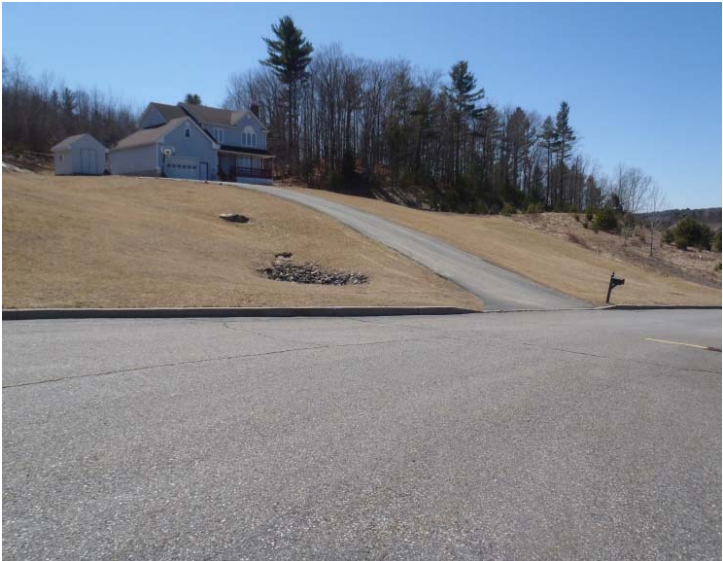
Driveways along Overlook Dr generally intersect the road surface at a steep angle and little or no apron resulting in significant gravel being carried into the road and ultimately the storm sewer system. Undeveloped lots remain around the cul-de-sac and could be encouraged to implement better driveway design.

Photo 1. Steep driveway intersection with Overlook Dr.

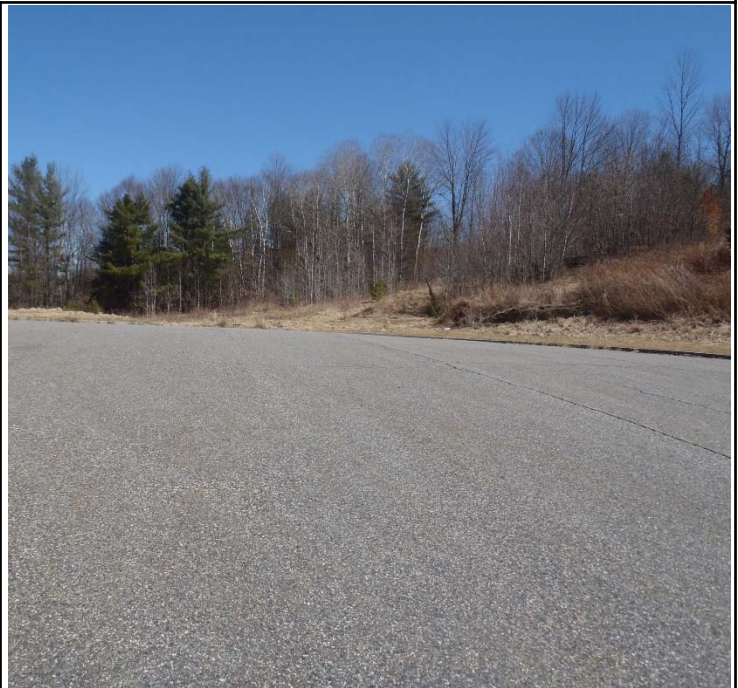
Photo 2. Cul-de-sac at end of Overlook Dr; additional driveways should be encouraged to intersect road with better geometry

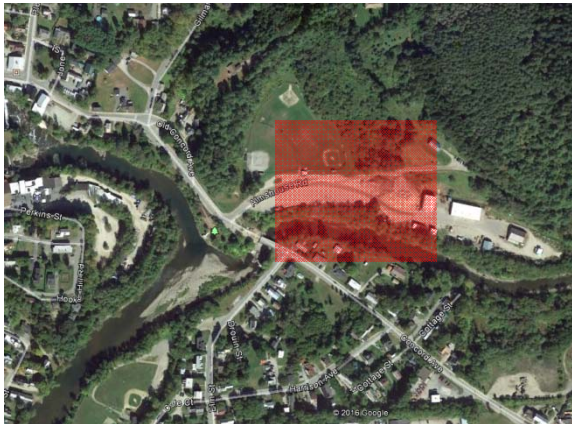
<b>Problem Area ID:</b> MR-03	<b>Latitude:</b> 44.252702	<b>Longitude:</b> -72.002680
<b>Watershed:</b> <hr style="border: 0; border-top: 1px solid black; margin: 2px 0;"/> Moose River

**Description of Observed Conditions:**  
 Almshouse Rd runs through a large gravel parking lot that drains overbank to the Moose River and provides access to the Town Garage and St. Johnsbury Municipal Forest. Some evidence of rill and gully erosion along streambank in areas where concentrated flow leaves the parking lot; during heavier rain events sediment flows down to Concord Ave also into the Moose River.

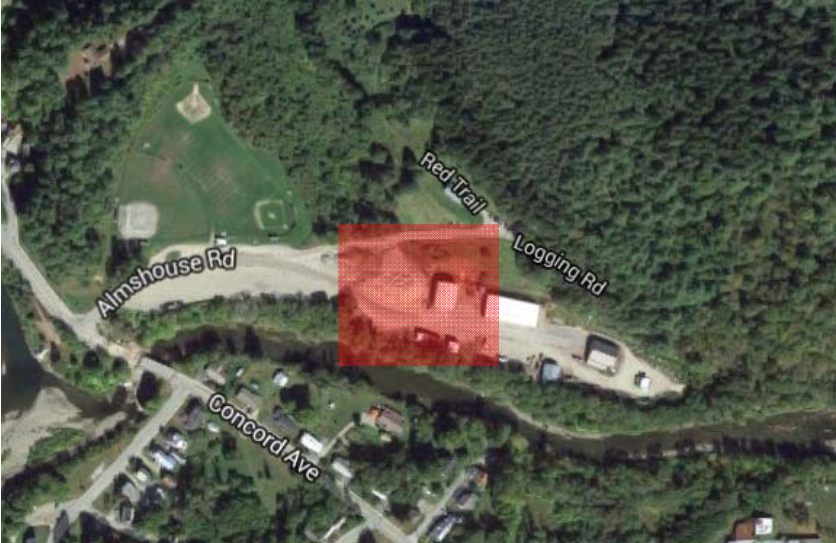
<b>Problem Area ID:</b> MR-04	<b>Latitude:</b> 44.424143	<b>Longitude:</b> -72.006645
<b>Watershed:</b> Moose River

**Description of Observed Conditions:**  
 Sand storage pile at the Town Garage is experiencing “creep” and has slumped over the jersey barriers intended to prevent material from eroding into a nearby drainage swale; both stormwater outlets from the facility show evidence of significant sediment transport and active erosion.

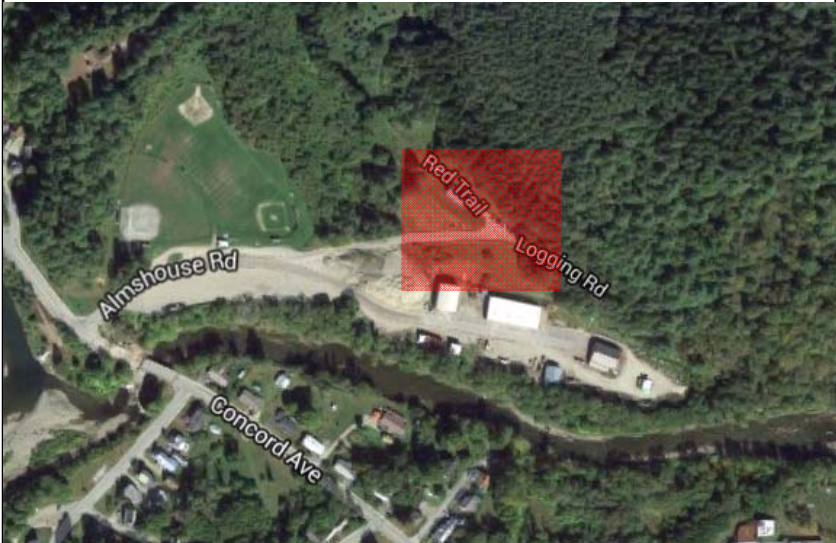
<b>Problem Area ID:</b> MR-05	<b>Latitude:</b> 44.42523	<b>Longitude:</b> -72.005856
<b>Watershed:</b> <hr style="border: 0; border-top: 1px solid black; margin: 2px 0;"/> Moose River

**Description of Observed Conditions:**  
 Visible erosion along the shoulder of the access road; currently at least a portion of runoff from the road and parking area contributes to the problems observed at the Town Garage.

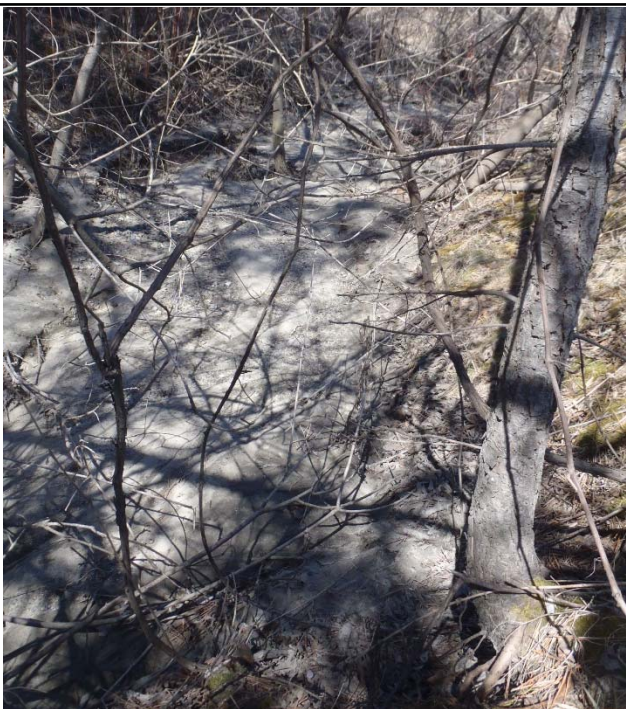
**Description of Observed Conditions:**  
 Large stockpile located in close proximity to the WWTP is actively eroding into a drainage swale; there is evidence of significant sediment transport to the Passumpsic River.

Photo 2. Evidence of significant sediment transport

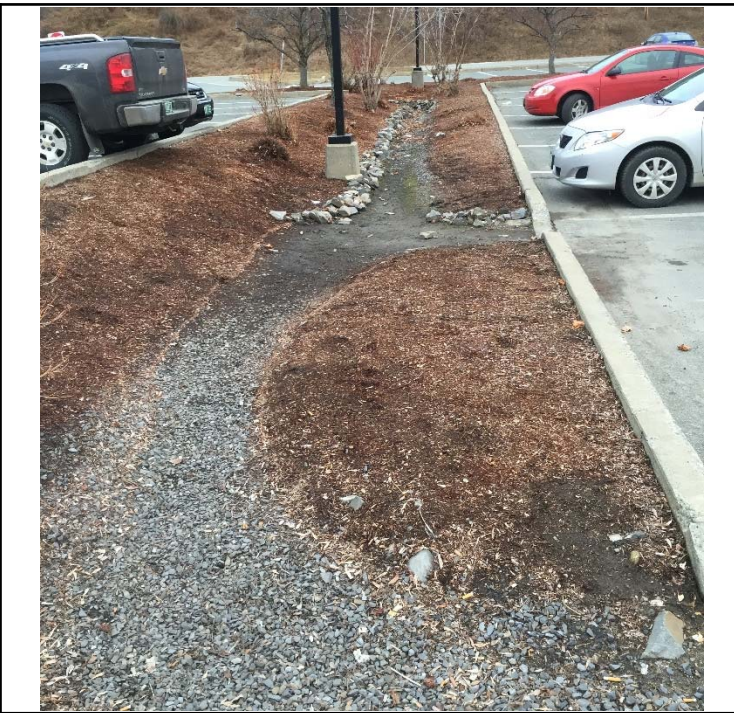
Photo 2. Underutilized, existing island in Price Chopper parking lot

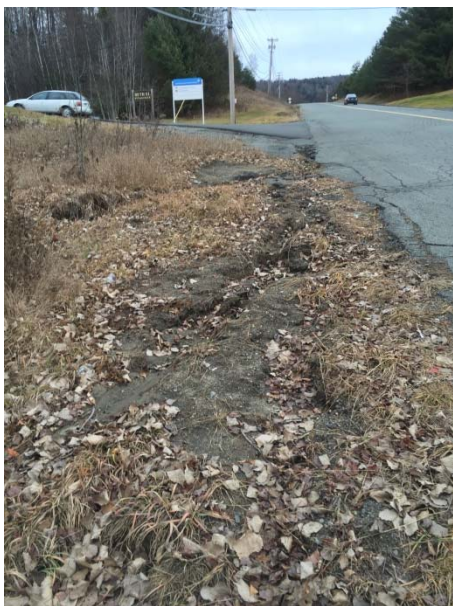
There are a number of small stormwater practices which appear to be designed to treat runoff from buildings and parking facilities along Sherman Dr., several of which appear unmaintained and potentially undersized, and are discharging onto a steep slope without energy dissipation. There are retrofit opportunities to use existing green spaces in the parking lots by recessing them and regrading to drain to these areas; swale along the north-side of the parking lot could be retrofit as a bioswale to provide enhanced stormwater treatment. Other parts of the campus are covered under an existing stormwater discharge permit (5099-9015).

Photo 1: Erosion along the road shoulder

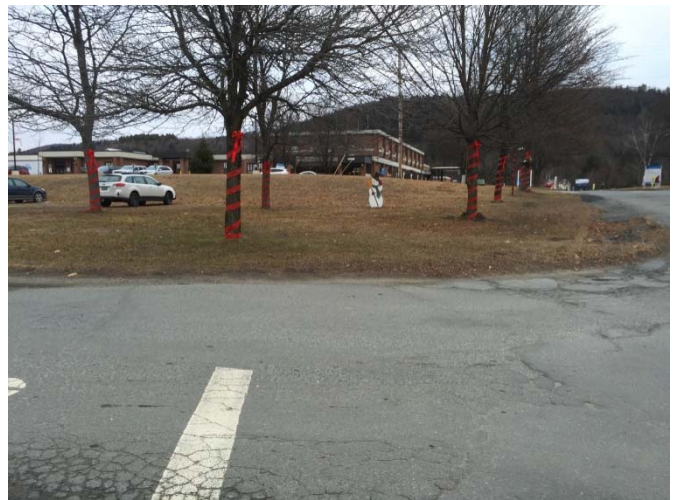
Photo 2. Green space and potential retrofit opportunity

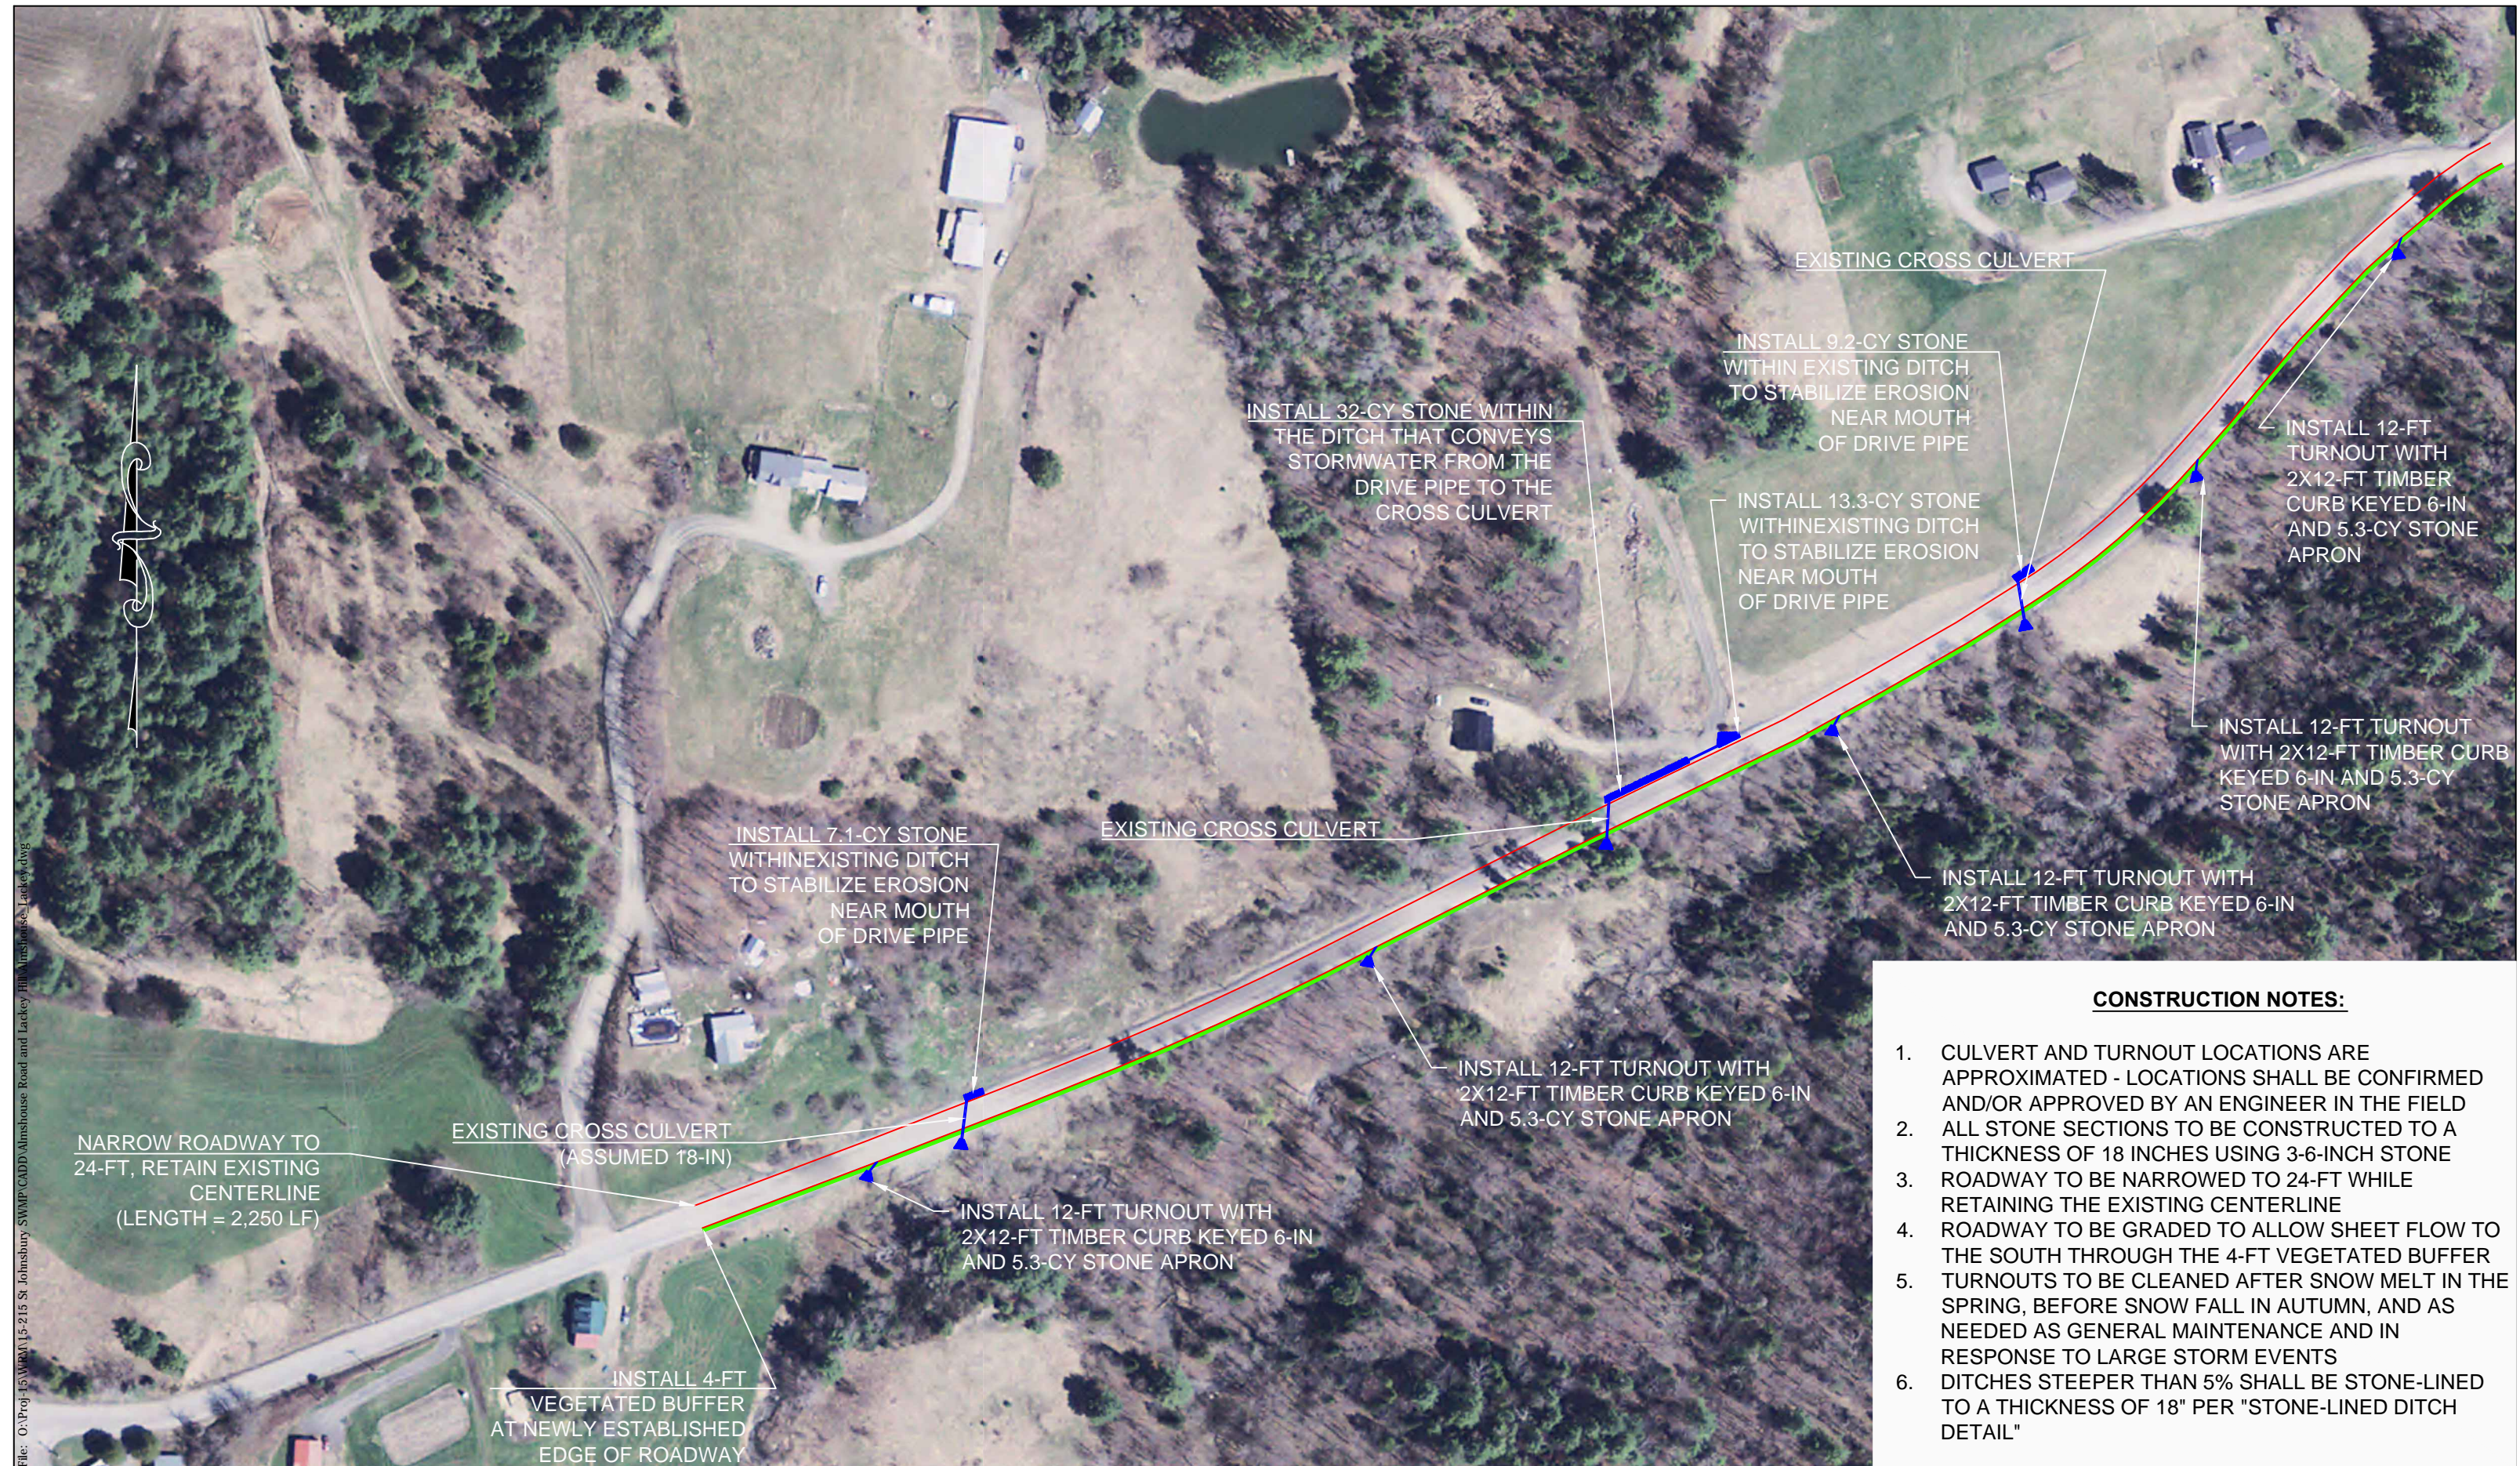
SAINT JOHNSBURY SWMP  
 PR-06 LACKEY HILL ROAD  
 STORMWATER IMPROVEMENTS LAYOUT  
 SAINT JOHNSBURY VERMONT

**Description of Observed Conditions:**  
 Unstable ditches, turnouts and cross-culverts are resulting in significant erosion and visibly more turbid water in Roberts Brook between Spaulding Rd and Breezey Hill Rd. Opportunity to bring overly-wide section of road back to standard width and establish properly shaped ditches, with stone-lining and check dams as needed.

1. CULVERT AND TURNOUT LOCATIONS ARE APPROXIMATED - LOCATIONS SHALL BE CONFIRMED AND/OR APPROVED BY AN ENGINEER IN THE FIELD
2. ALL STONE SECTIONS TO BE CONSTRUCTED TO A THICKNESS OF 18 INCHES USING 3-6-INCH STONE
3. ROADWAY TO BE NARROWED TO 24-FT WHILE RETAINING THE EXISTING CENTERLINE
4. ROADWAY TO BE GRADED TO ALLOW SHEET FLOW TO THE SOUTH THROUGH THE 4-FT VEGETATED BUFFER
5. TURNOUTS TO BE CLEANED AFTER SNOW MELT IN THE SPRING, BEFORE SNOW FALL IN AUTUMN, AND AS NEEDED AS GENERAL MAINTENANCE AND IN RESPONSE TO LARGE STORM EVENTS
6. DITCHES STEEPER THAN 5% SHALL BE STONE-LINED TO A THICKNESS OF 18" PER "STONE-LINED DITCH DETAIL"

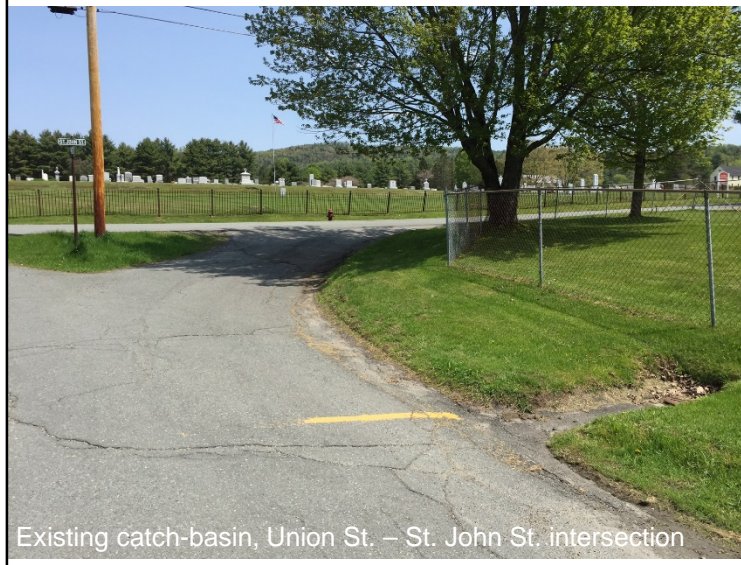
Existing catch-basin, Union St. – St. John St. intersection

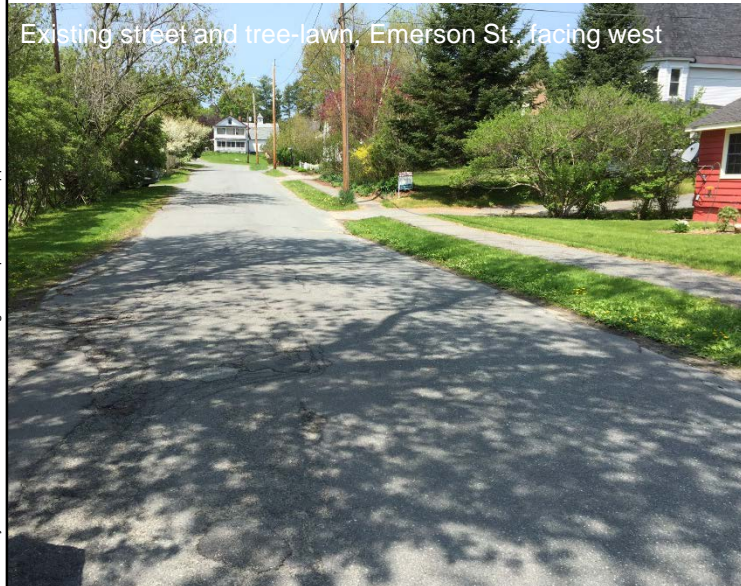
Existing street and tree-lawn, Emerson St. facing west
